# Shaft for Roller at Inlet and Exhaust Valve Guide

February 2009 SI 09-508/JFM

Owners and Operators of MAN Four-stroke Diesel Engines Type L16/24.

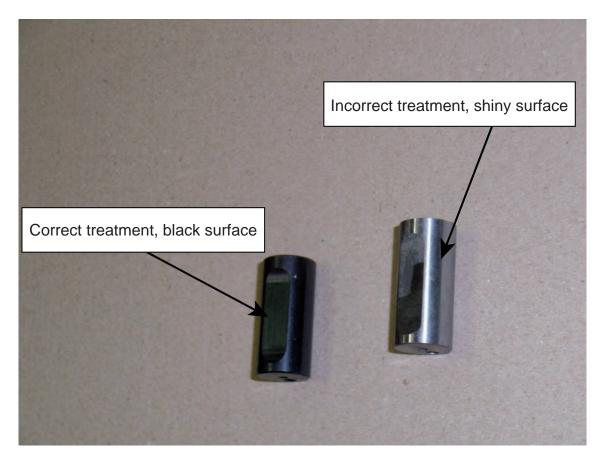
Fig 1.

The affected shafts do have a shiny surface, these may be scrapped, shafts with correct treatment can be determined as they appear black at the surface, see below picture fig 1. Shafts with incorrect treatment will be replaced free of charge.

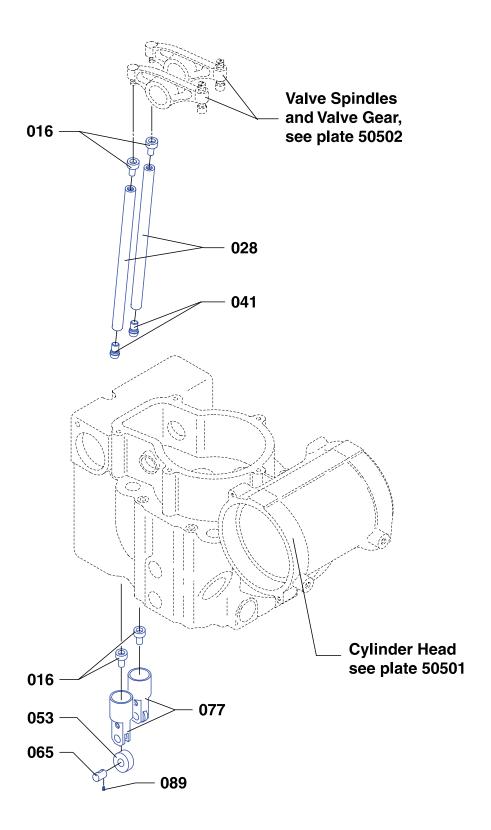
Plate Page 1 (2)	Roller Guide and Push Rods	50801-02H
---------------------	----------------------------	-----------

From one of our subsuppliers we have been informed that a batch of shafts delivered for the roller guide at our L16/24 engine type is not produced in accordance with our specification and subsequently does not fulfil our specification in respect of hardness.

The shaft is shown on Plate 50801-02H as Item 065, shaft for inlet and outlet roller guide, Plate attached for reference.

As we are not able to trace the supplies of each shaft piece we recommend to check the shafts found in your stock in order to avoid these to be installed.

For engines in service we recommend to carry out inspection of inlet and exhaust rollers and cams as a preventive maintenance check.

In case, abnormal wear or damage is found at the rollers or cams we recommend to carry out an inspection of the roller guide in order to determine if the installed roller guide shaft is from the affected batch (shiny type). We recommend that the roller guides are inspected in connection with the first 12,000 running hours overhaul at the latest.
