**Broken Camshaft Bolts (M16 - quality 12.9)**

June 2010  
SL10-536/MNA

Owners and Operators of MAN  
Four-stroke Diesel Engines Type  
Propulsion L27/38.

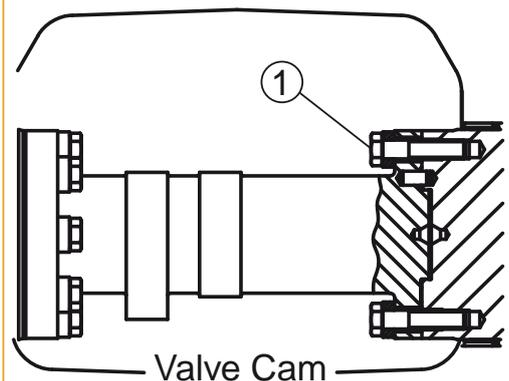
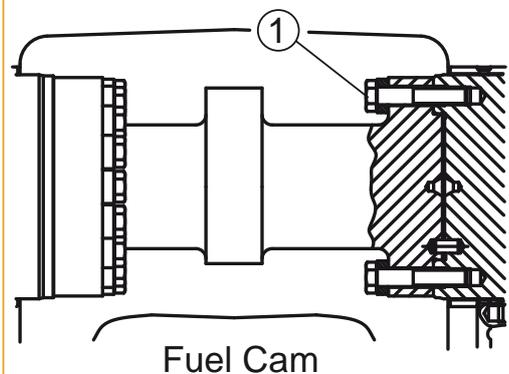
In few cases we have received reports that one or two bolt heads (Item 1) have broken off on a camshaft section. In these cases we have recalled the bolt for further investigations to determine the root cause. These investigations revealed that the bolts have either been over-tightened or exposed to corrosion.

By the above-mentioned solution we eliminate also the brittle sensitivity when an M16 - quality 10.9 bolt is installed.

Check if any bolts are loose or if bolt heads have broken off. We recommend that the camshaft bolts are checked at intervals of 2000 running hours. If bolts are found broken or loose, all bolts should be replaced by new M16 - quality 10.9 bolts, lubricated with lube oil and tightened with 250 Nm.

**It is very important that the thread holes for the bolt are cleaned from old grease and oil before new M16 - quality 10.9 bolts are installed, in order to secure correct tightening torque.**

**Please be aware that the thread types for the valve cam and the fuel cam are not the same specification. Therefore, when purchasing new bolts, please do not hesitate to contact us for correct specification of the necessary parts.**
