Low Load Operation

2011 Update

SL11-544/MTS

Owners and operators of MAN B&W two-stroke marine diesel engines.
Types: MC/MC-C and ME/ME-C/ME-B

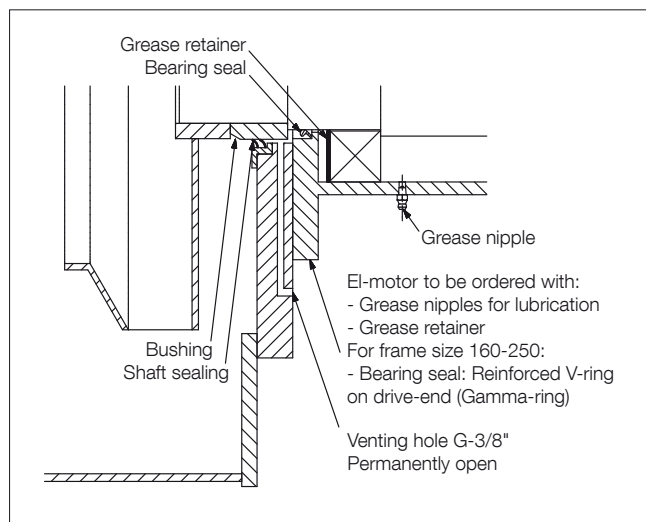
On some occasions, a contributing factor has been that the A/B flange venting hole for shaft sealing leakage has been plugged, thereby introducing a large risk on the bearing in case of a leaking shaft sealing.

If the shaft seal is leaking, and the venting hole is plugged, the scavenge air pressure will push air, sludge and impurities from the scavenge air through the bearing and, thereby, remove the lubricant from the bearing.

Fig. 1: Cut out of A/B wheel/shaft/flange

It is recommended to check the venting hole on all auxiliary blowers, and remove the plug if installed. A drain from the venting hole to the frame box drain should be arranged in order to avoid oil spills below the blowers. Change the shaft sealing if an excessive air amount is experienced from the drain.

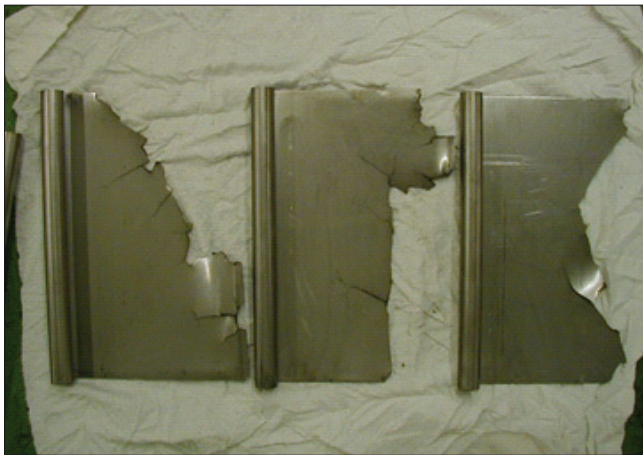
There have been several reports of broken flap valves in connection with low-load operation.

At some point in the load area around the switch point of the A/B, the flap valves (non-return valves) in the scavenge air receiver will be continuously opening and closing due to the pressure pulsations in the scavenge air receiver. This load area can be recognised by a distinct hammering noise

from the flap valves. The hammering of the valves will damage and/or break the valves after a short period.

Fig. 2: Broken flap valves

Broken and missing valves will have a negative impact on the engine performance when the auxiliary blowers are running.

Operating the engine continuously in this load area must be avoided, and the load area should be passed as fast as possible.

Broken and damaged valves must be changed at first opportunity, and valve pieces should be removed from the scavenge air space to prevent them from causing damage downstream.

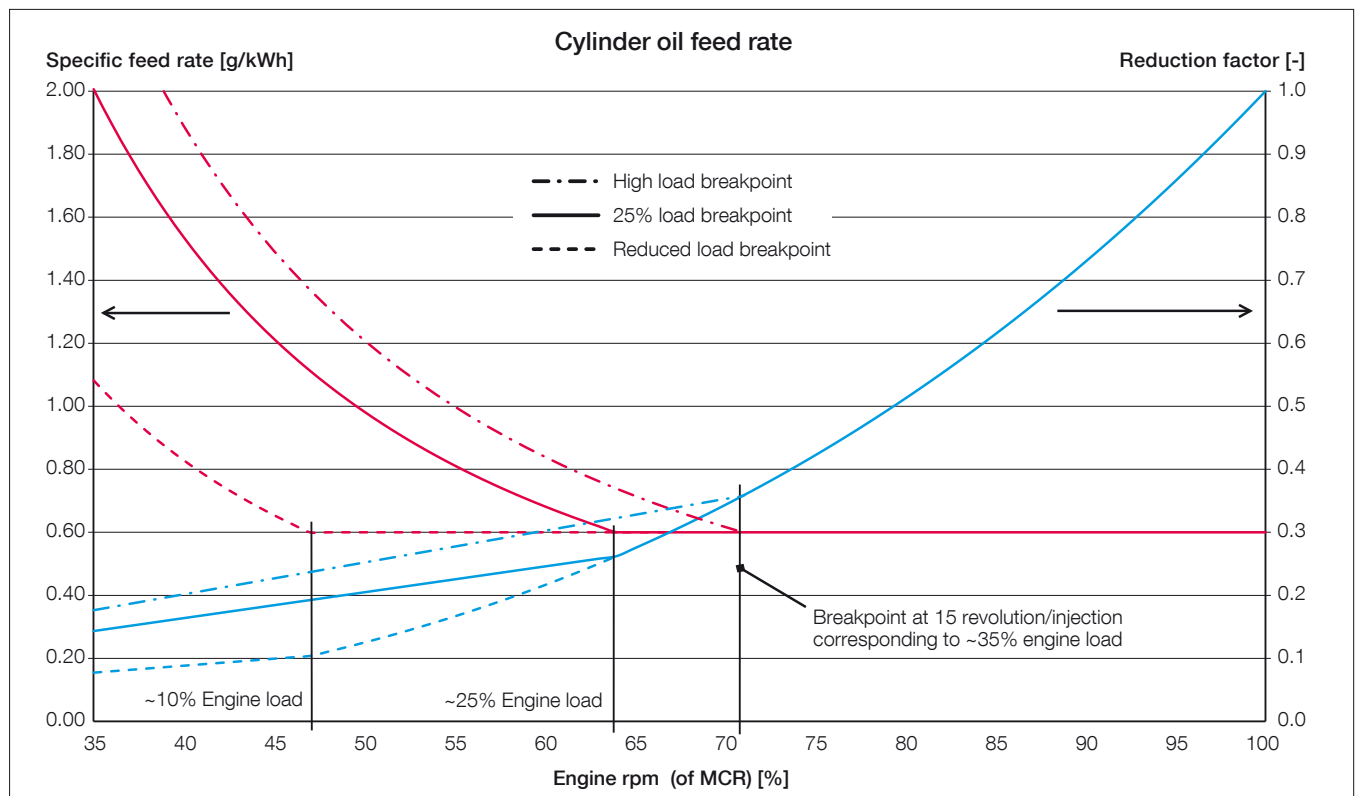
The intention is to switch from load-proportional control to rpm- or mep-proportional control below 25% engine load. However, on mechanically controlled MC/MC-C engines, the Alpha Lubricator system has a limit of max. 15 rev. between injections in order to avoid too long intervals between lube injections. In most cases, this means that rpm-proportional lube oil control will start already at 35-40 % load. This may result in excessive lubrication at very low loads (10% load), which could lead to deposit build-up on the piston top lands.

As illustrated in Fig. 3, the specific feed rate could, potentially, be reduced significantly if the 15 rev./inj. limit is reached too early. The feed rate could easily be halved if a constant specific feed rate, following the power algorithm, down to 10% engine load is applied.

Fig. 3: Alpha Lubricator feed rate algorithm

To reduce the breakpoint load, smaller Alpha Lubricator pumps can be retrofitted whereby the load proportional

breakpoint can be moved down to a lower engine load. Depending on the load pattern of the engine, this modification could show profitable, and it would reduce the fouling of the scavenge air space with excessive lube oil.
