**Action code: WHEN CONVENIENT****Ridge Wear at Crankpin Journals**

Replacement of SL2017-647/JNN

SL2018-667/JNN  
November 2018**Concerns**Owners and operators of  
MAN four-stroke diesel engines.

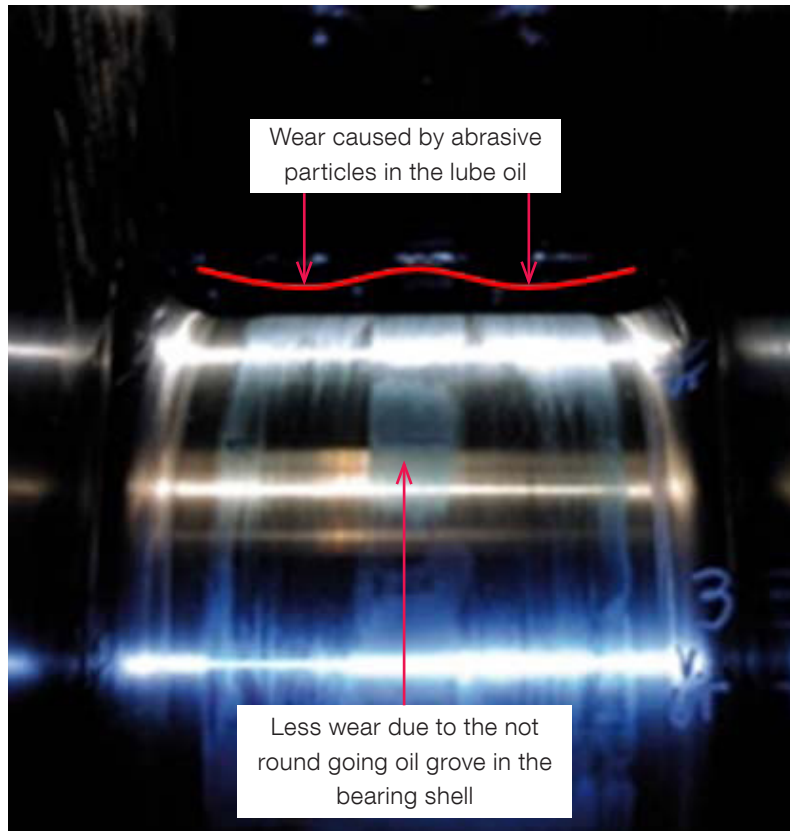
Ridge wear can be observed as wear on both sides of the centre of the crankpin journal. Ridge wear is often observed 15-60° after BDC, but can be extended to larger part of the journal.

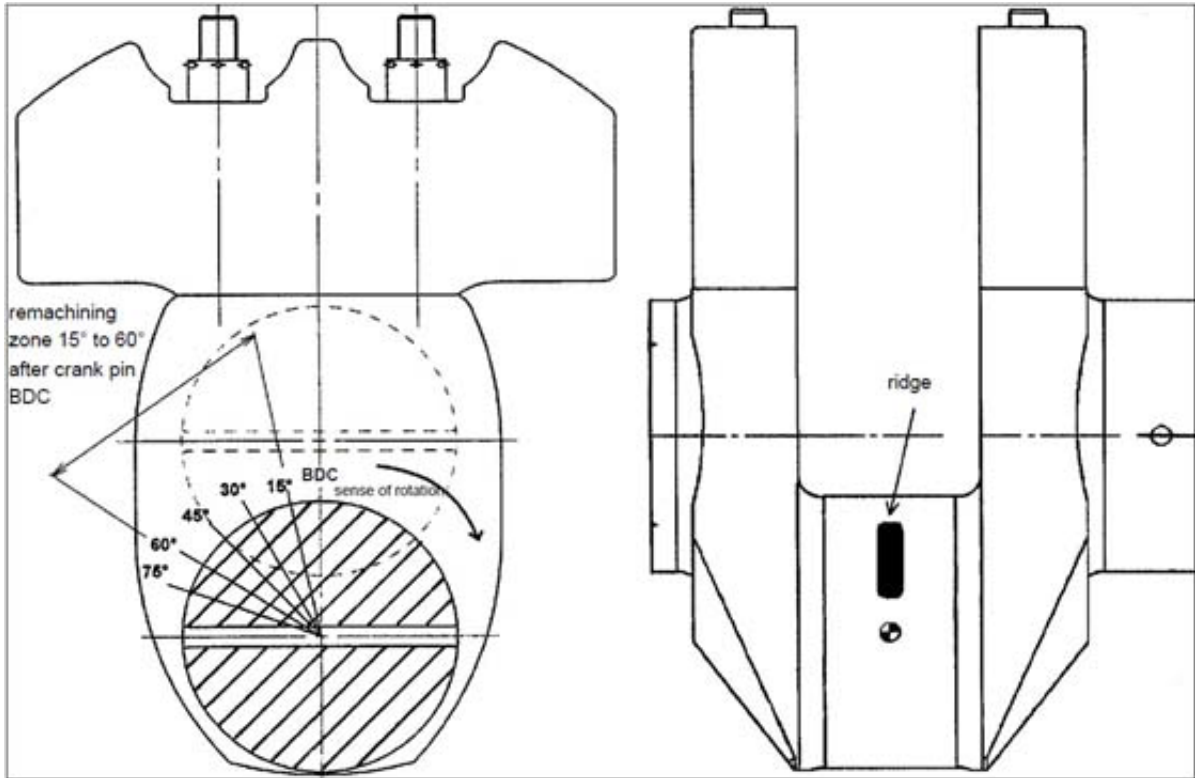
The sketch shows the location of the ridge wear in the highest loaded zone 15-60° after BDC.

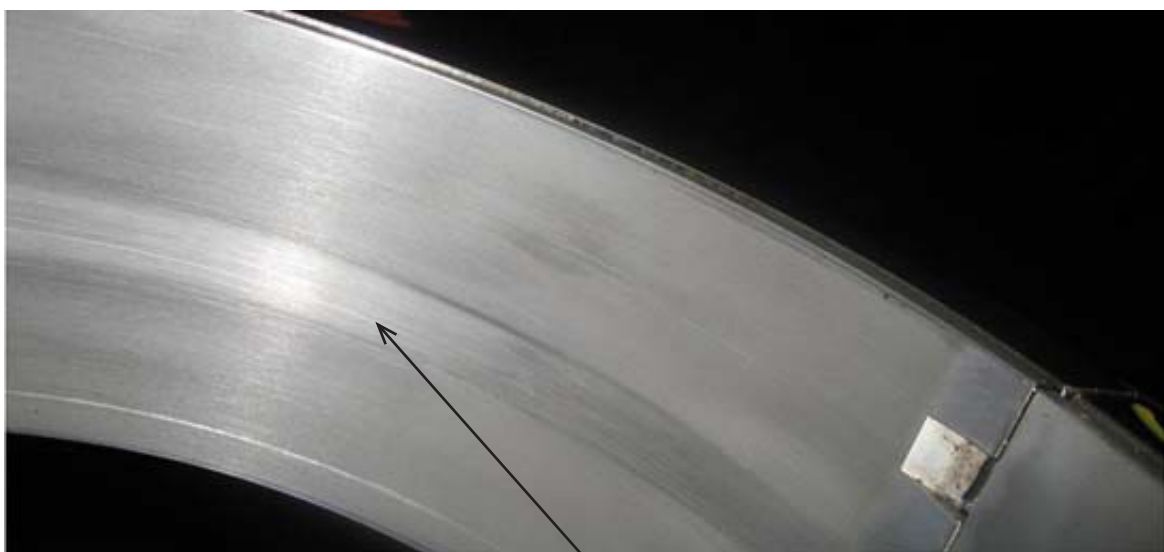
Careful inspection and judgement of the crankpin journals must be carried out whenever a new crankpin bearing is installed. In case ridge wear is observed this must be rectified before new upper and lower bearing shells are installed. In case rectification is not carried out, the bearing damage as shown in the following will occur after a few hours of operation. In case of continuous operation serious damage might occur to the bearing and journal.

Bearing shell with damage from ridge wear.

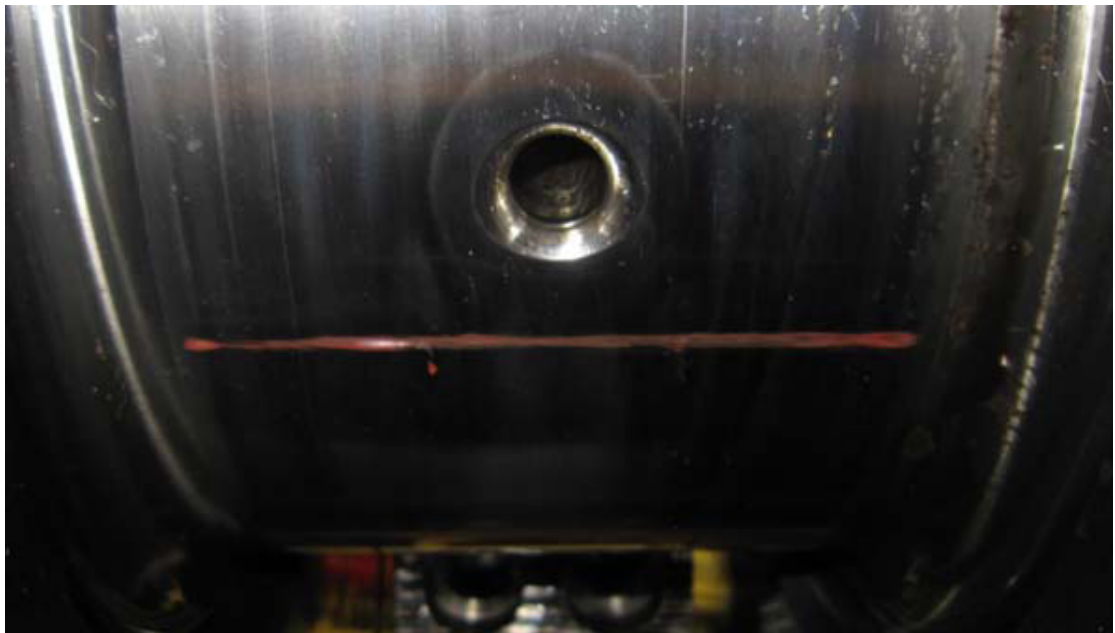
Contact test at a journal with no ridge wear, indicated by an unbroken line of the marking paste.

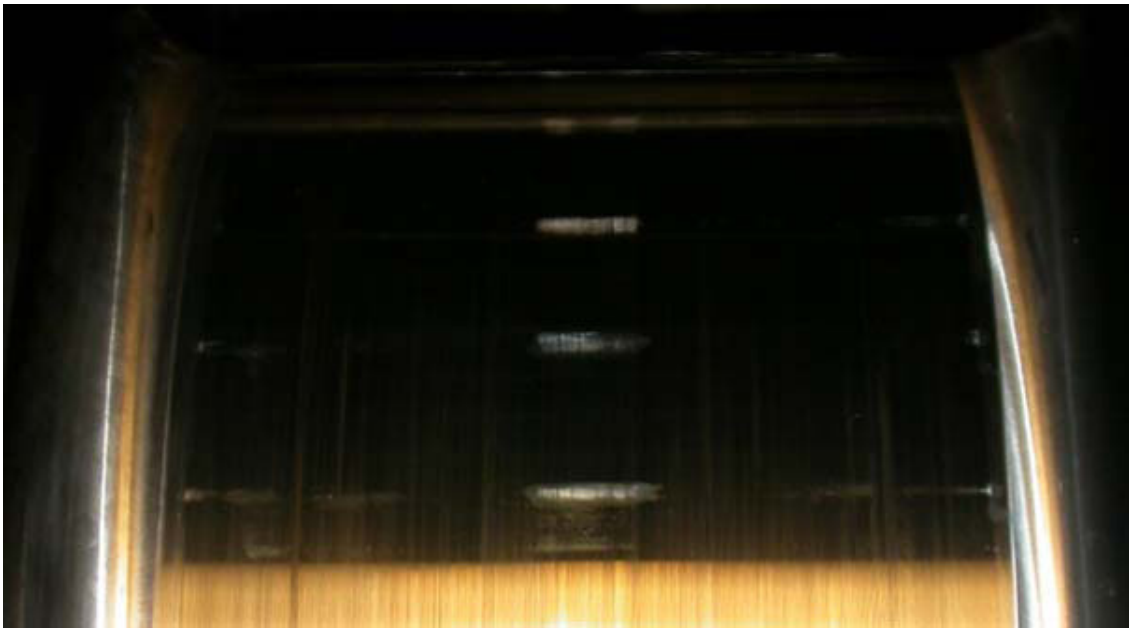
If there are indications of ridge wear, the line will be broken and look similar to the picture below. The broken line will look different from case to case since the depth and shape of the ridge wear will be different.

Example of journal with ridge wear – indicated by the broken lines of the marking paste.

Depending on the depth of the ridge wear, the affected journals must be polished or, in the worst case, machined to undersize.

- < 5 micron: no action needed
- > 5-50 micron: polish the journal with 400 grid emery cloth mainly in the center of the journal in order to remove or bring the ridge wear below 5 micron. In case of excessive ridge wear, machining of the journal may be needed.
- > 50 micron: machining of the journal to undersize is recommended.

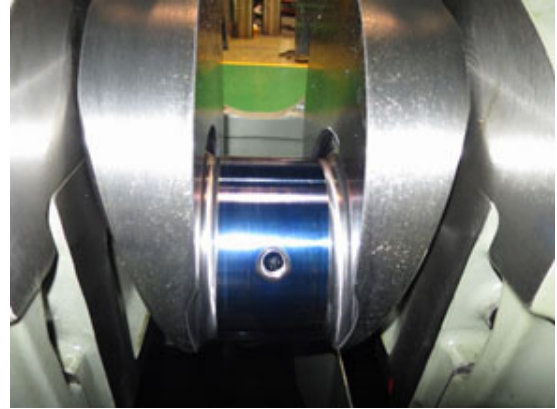
Contact area at crankshaft in engine

The contact area is assessed visually. After polishing a contact area of minimum 70% must be obtained. The surface of the journal must not be convex or concave.
