Sulphur corrosion package

SL2019-677/JNN

Owners and operators of
MAN four-stroke diesel engines.

Marine: L21/31

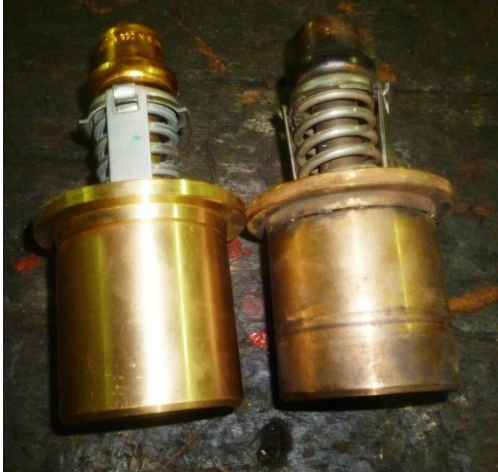
Due to the above, it is crucial to maintain a correct cooling water temperature in the high temperature (HT) circuit of the engine. Therefore, we draw attention to the importance of frequent checking of the engine performance parameters, including the HT cooling water temperature. In case the temperature has decreased beyond the normal values mentioned in the instruction manual, we strongly recommend inspecting the HT thermostatic elements. Our service department has reported cases with failing thermostatic elements caused by corrosion / cavitation on the sealing surface of these, see the following pictures for reference.

New and used valve elements

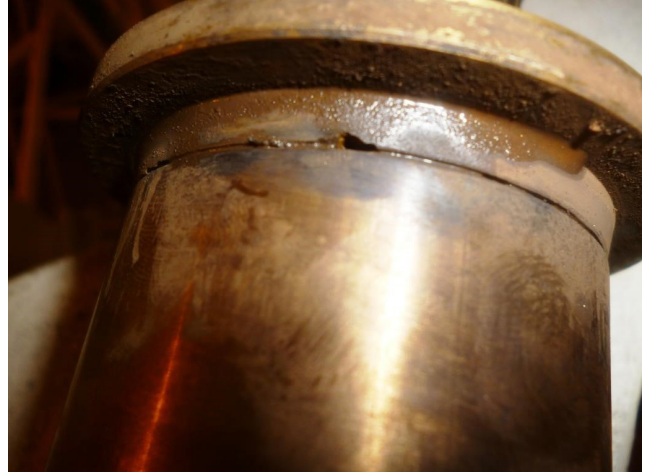
It is caused by condensation of sulphur acid on the relatively cold wall of the exhaust duct. High sulphur contents and operation at low load accelerate the corrosion.

Corrosion / cavitation on sealing surface

If sulphur corrosion cannot be avoided by maintenance of the cooling water system, we have prepared a retrofit cooling water temperature control package aiming to increase the temperature on the exhaust duct wall.

By increasing the cooling water temperature and locally reducing the water flow in the cylinder head, the wall temperature in the exhaust duct will rise, and hereby possible condensation of sulphur acid will be reduced.

- A 31-mm restriction to be installed for cooling water flow control through the engine. It must be installed in the common water outlet pipe from the cylinder heads (1 pc/engine).
- A plug screw with 2.5-mm hole for local flow control at the cylinder head. It must be installed in the cooling water jacket (1 pc/cylinder).
- The HT cooling water thermostatic elements are to be changed from 79°C to 85°C (3 pcs/engine).
