Check of wiring for actuator

SL2019-678/JNN
August 2019

Owners and operators of
MAN four-stroke diesel engines.

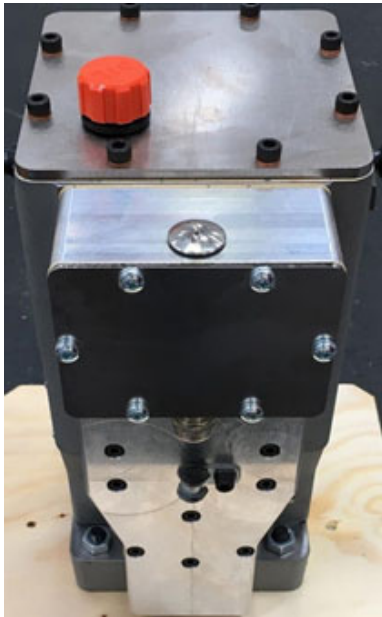
Terminal box with cover

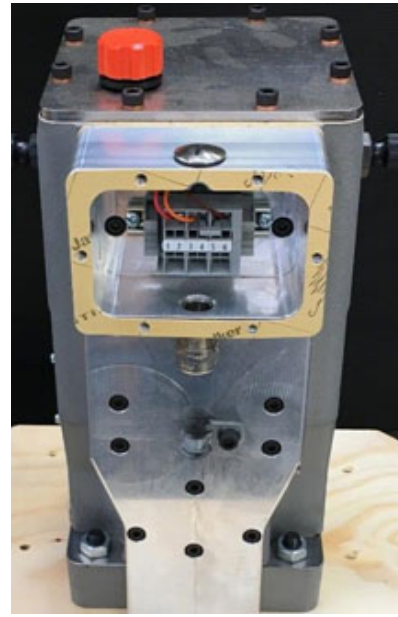
Cover removed from terminal box

After reconnecting the wires, it must be ensured that no wire can be in contact with the cover. Remove the six screws in the front cover of the actuator to get access to the terminal strip.

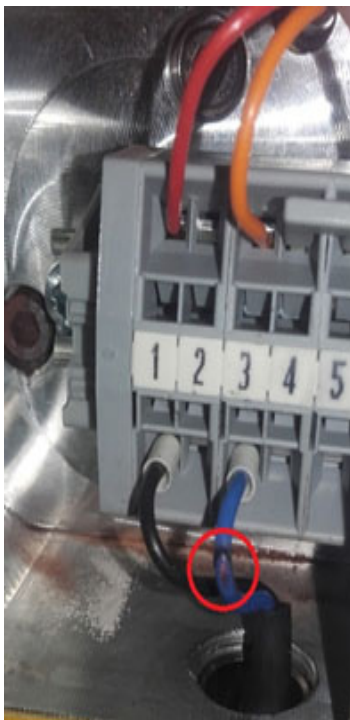
In the cases reported, an insulation failure has occurred on the wiring connecting the control module to the speed actuator. The cause for the insulation failure has been located to the wiring in the terminal box on the actuator.

Worn-off wire insulation

As a precaution, we recommend to inspect the wiring in the terminal box at the first opportunity. At the inspection, it must be checked that the connection is installed in such a way that the wires do not touch the cover of the connection box. In case of any signs of wear on the insulation of the wires, the damaged part is to be cut off. The connection terminals are of the spring-loaded type, ferrules may be applied at the cables, we however in this particular case recommend removing the cable ferrules, if installed, and connect the wires directly in the terminal strip.

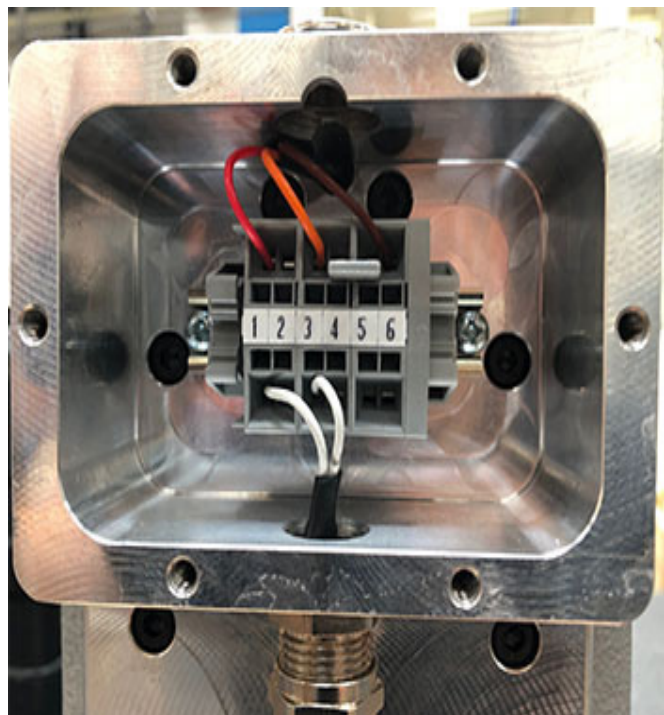
Correct wiring without wire ferrules
