Preventive grinding of exhaust valve seats

SL2022-729/AGC
September 2022

Owners and operators of MAN B&W two-stroke marine combustion engines.
Type: All 30-98 bore engines with exhaust valve seats of the wide seat type.

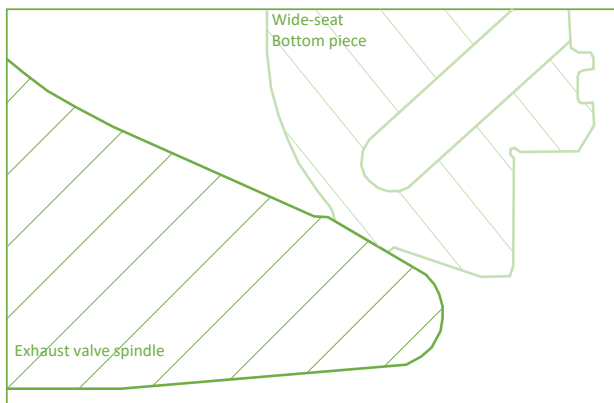
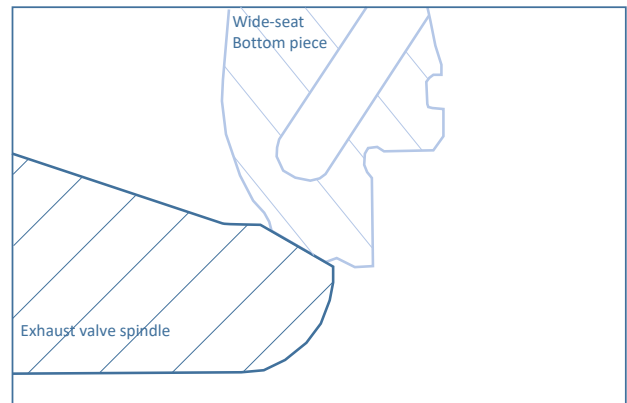
Spindle seat seen from top.

In the event of dent marks exceeding Ø2 mm after 0.5 mm spindle seat grinding, evaluate according to the sketch below.

***) Seat contact area: spindle seat >< bottom piece seat.**

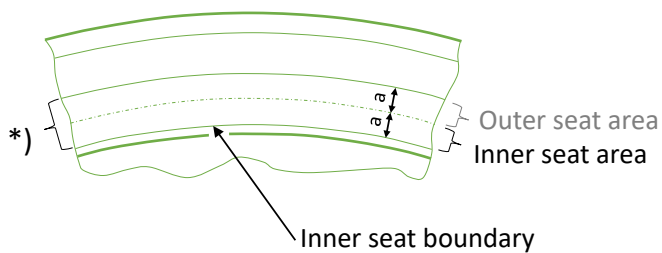
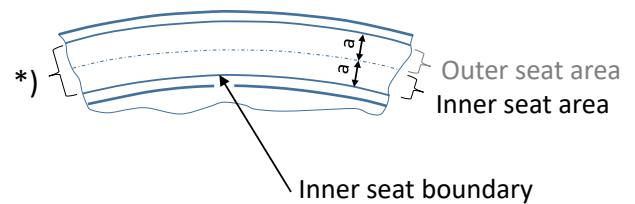
Spindle outer seat area

Dent marks exceeding Ø2 mm can be allowed, but the size must not exceed 8 mm size in any direction, and the dent mark must not affect the inner seat area.

Spindle inner seat area

Dent marks exceeding Ø2 mm cannot be allowed on the inner seat area, except if the following conditions are fulfilled for that particular dent mark:

1. Minimum distance from dent mark to inner seat boundary is above 4 mm.
2. No visible sign of V-shaped hot corrosion or “elephant skin” in connection to the dent mark.
3. Largest dimension of dent mark may not exceed 4 mm in any direction.

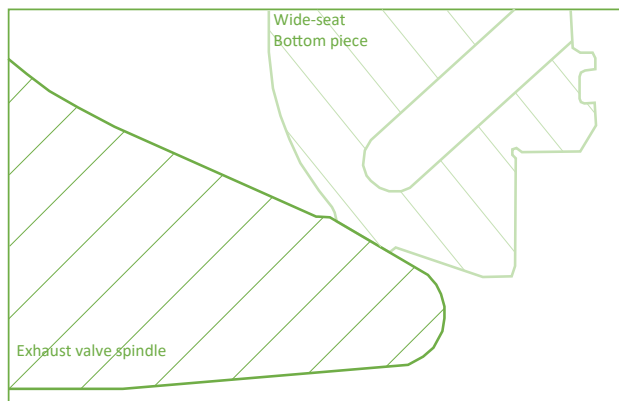
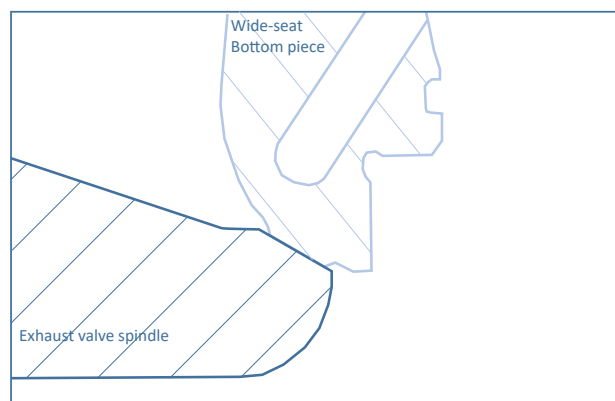
Spindle seat seen from top.

Defects necessitating rejection or repair.
The sketches below are valid for spindle seats.

*) Seat contact area: spindle seat >< bottom piece seat.
 All below examples to be rejected for further use.

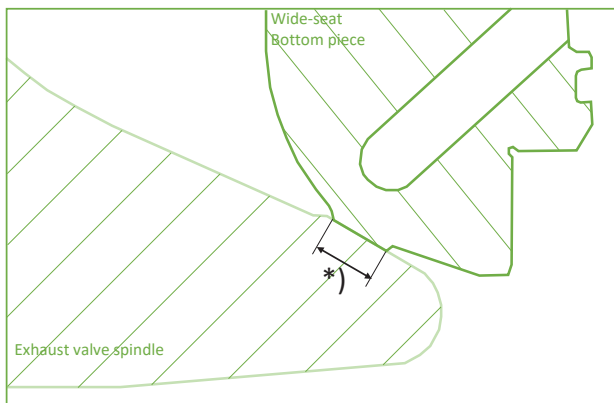
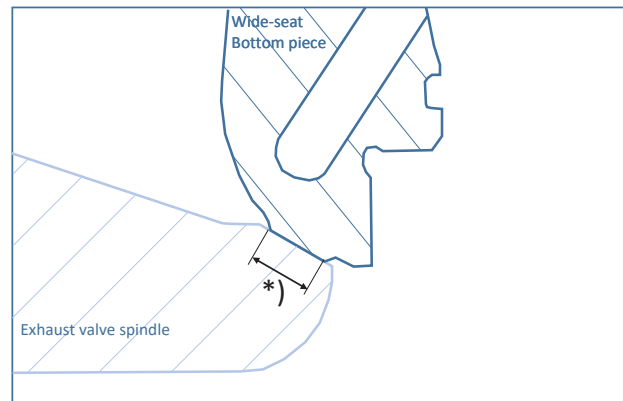
**Bottom piece seat seen from below.**

Service acceptance criteria for bottom piece seat.

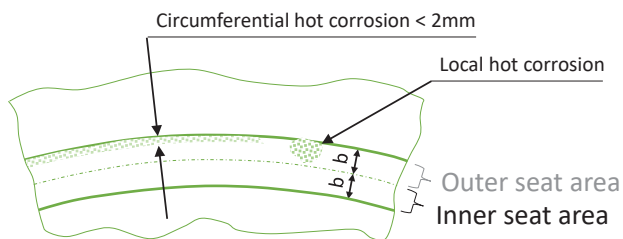
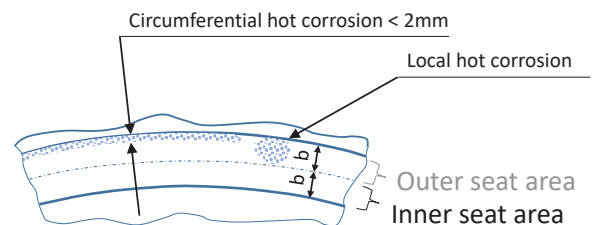
**Bottom piece outer seat area**

- Hot corrosion at the outer boundary of the bottom piece seat area must not exceed 2 mm width.
- Local hot corrosion on the bottom piece outer seat area, and only affecting the outer seat area, can be accepted if the maximum size in any direction does not exceed half the seat length. Half seat length indicated with “b” in the sketch above. Maximum one local hot corrosion spot of half seat length size can be accepted.
- Dent marks exceeding Ø2 mm can be allowed on the outer seat area provided that the inner seat area is unaffected.

Bottom piece inner seat area

Dent marks exceeding Ø2 mm cannot be allowed on the inner seat area, except if the following conditions are fulfilled for that particular dent mark:

1. Minimum distance from dent mark to inner seat boundary is above 4 mm.
2. Largest dimension of dent mark may not exceed 4 mm in any direction.
3. No visible sign of V-shaped hot corrosion or “elephant skin” in connection to the dent mark.

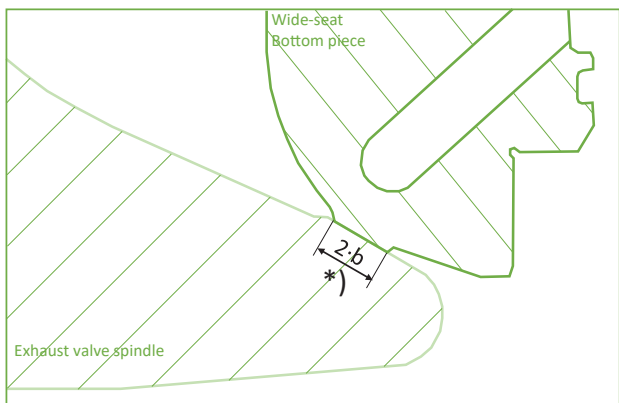
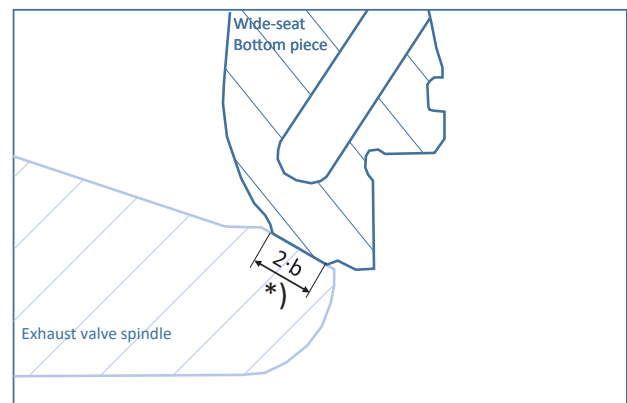
Bottom piece seat seen from below.

Defects necessitating rejection or repair.
The sketches below are valid for bottom piece seats.

All below examples to be rejected for further use.
