### Reconditioning of exhaust valve spindles

Do not recondition some spindle types until further notice

SL2023-735/AGC  
April 2023

Owners and operators of MAN B&W two-stroke marine combustion engines.

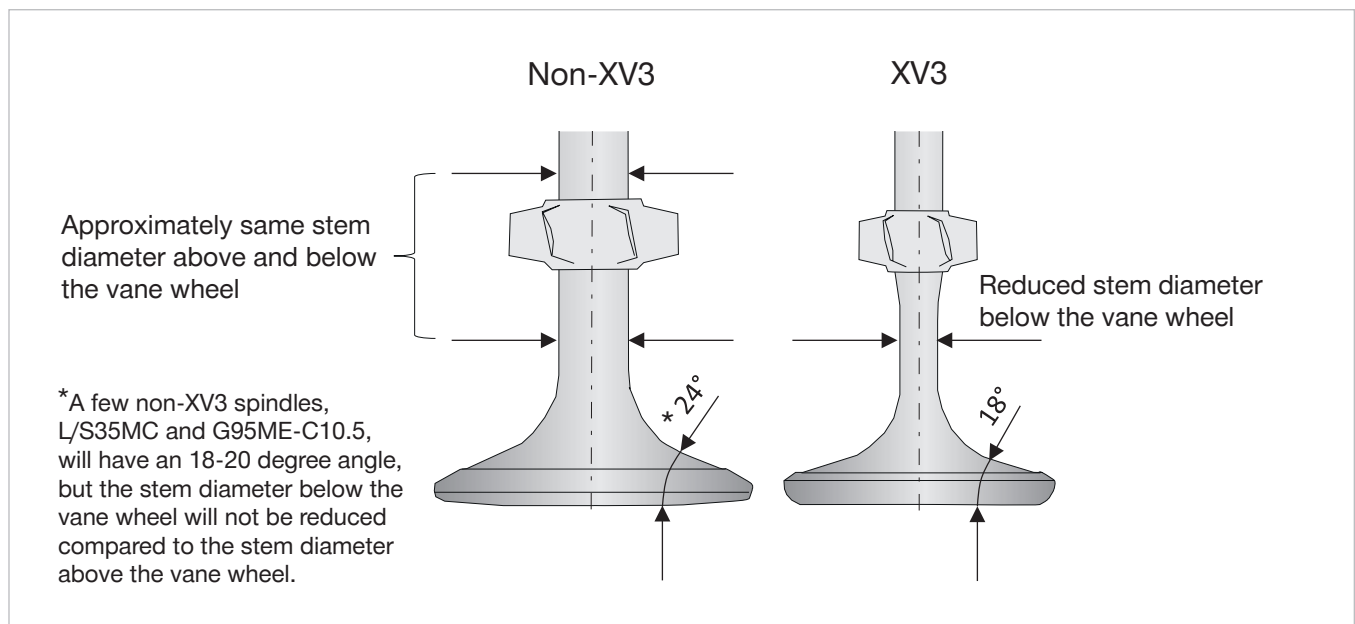
Fig. 1: Exhaust valve spindle types

All XV3 type spindles have:

- Smaller stem diameter below the vane wheel compared to above the vane wheel.
- 18° degree angle between the spindle disc bottom and the spindle disc top.

All non-XV3 spindles have:

- Approximately same stem diameter above and below the vane wheel.
- 24° degree angle between the spindle disc bottom and the spindle disc top (see Fig. 1).

Spindle reconditioning of non-XV3 design is still possible provided the spindle is of the Dura or Nimonic type.

- Dura spindles in all bore sizes can be reconditioned with IN718 on the seat and IN625 on the disc bottom.
- Nimonic80A spindles in all engine sizes can be reconditioned with IN718 on the seat and IN625 on the

disc bottom. Note that an IN718/IN625 reconditioned Nimonic80A spindle will experience a degrade in toughness compared to the original fully-forged Nimonic80A spindle and, as regards heat load, will perform like the less heat-resistant Dura-type alternative.

- Maximum two times re-welding regardless of bore size.
  - Three times re-welding, as allowed since SL2013-573/JAG August 2013, no longer applies.
  - Service experience has shown that three times re-welding is rarely applied, and spindle cracks in re-welded spindles has shown that three times re-welding cannot be allowed.

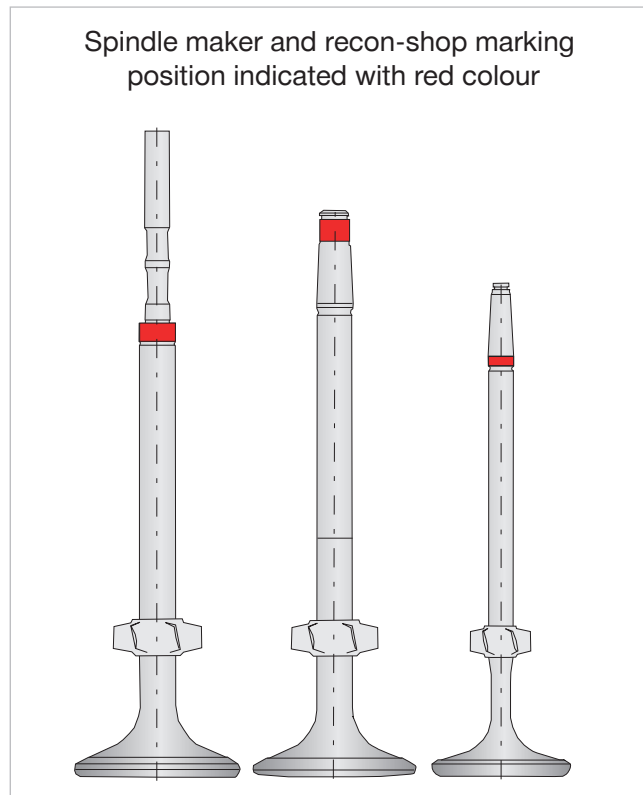
Fig. 2: Spindle marking position

If the spindle marking was performed in accordance with MAN Energy Solutions guidelines, the following marking should clarify which spindle material was utilised originally when the spindle was new and prior to any reconditioning, see Fig. 2.

Spindle marking:

- SEAT
- HEAT RESISTANT LAYER

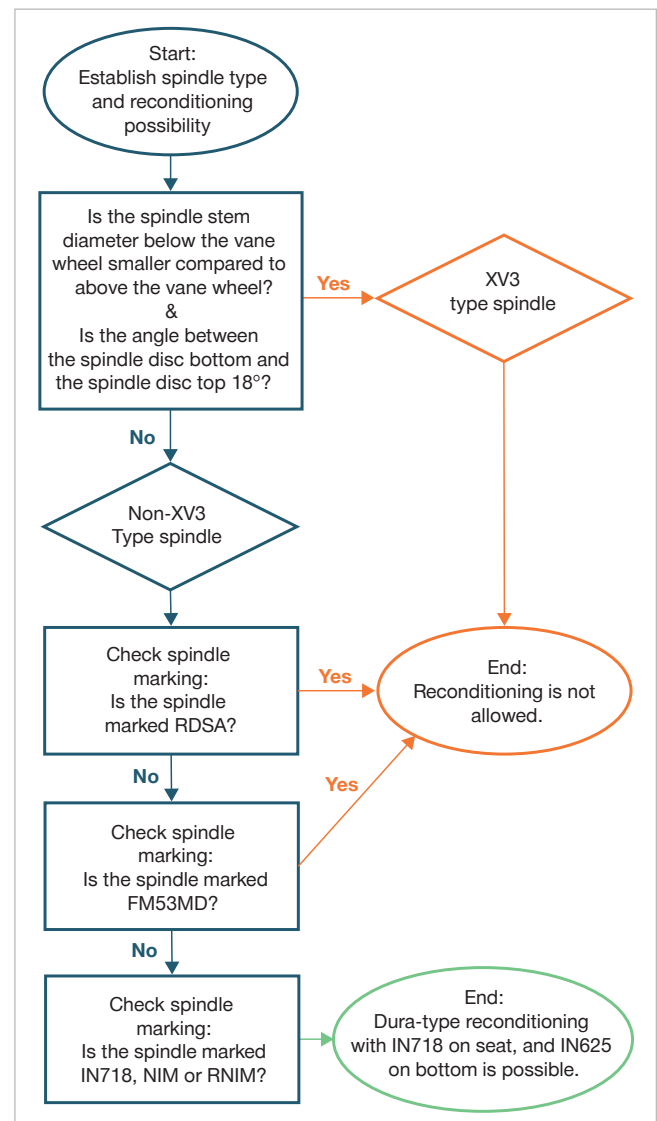
Fig. 3: Flow diagram – spindle types

We recommend using the flow diagram in Fig. 3 and Table 1 to evaluate whether or not spindle reconditioning is possible.

Spindle marking	Definition	Consequence
<b>RDSA</b>	Seat made of rolled DSA760	No reconditioning available regardless of the spindle type
<b>FM53MD</b>	Spindle bottom corrosion layer made of FM53MD	No reconditioning available regardless of the spindle type
<b>RNIM</b>	Seat made of rolled Nimonic80A	No reconditioning available if the spindle type is XV3
		Dura-type reconditioning is available if the spindle type is non-XV3
<b>NIM</b>	Seat made of Nimonic80A without rolling applied (older-type spindles)	Dura-type reconditioning is available if the spindle type is non-XV3
<b>IN718</b>	Seat made of rolled Inconel 718	Dura-type reconditioning is available

In case a spindle needs reconditioning before our procedure is available, the worn spindle should be put on stock until reconditioning becomes available.
