MAN Energy Solutions

Updated procedure due to potential crack in piston crown Replaces SL2023-743

SL2023-747/PRP November 2023

Work Card No. <u>8865-4204-0001</u> Special piston lifting

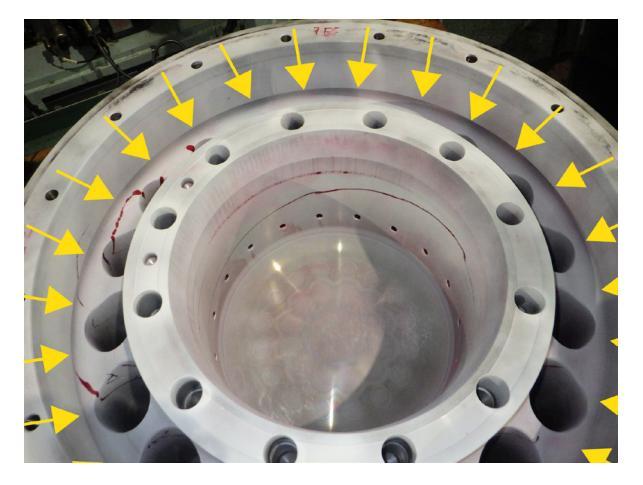
We have received a report from the owner of an MAN B&W engine where the engine crew became aware of a crack in the piston crown at the bolted connection.

In a situation where the contact face on the piston crown towards the piston rod breaks off, the piston rod will either fall sideways or drop, depending on the circumstances. This poses a serious potential risk to people and property, and may even result in bodily injuries and/or fatal casualties.

Additionally, in the event that such cracks develop, they can lead to an oil spill inside the engine. Such oil spills can be detected at the scavenge drain. If undetected for a long time, oil spills might, in rare cases, lead to substantial engine damage that potentially could result in a complete breakdown.

Fig. 1: Dye check revealing cracks in piston crown (yellow arrows indicate the crack line)

When dismantling the piston, we recommend checking for cracks in the bolted connection in the inner circular contact surface. If you find a crack, replace the piston crown.

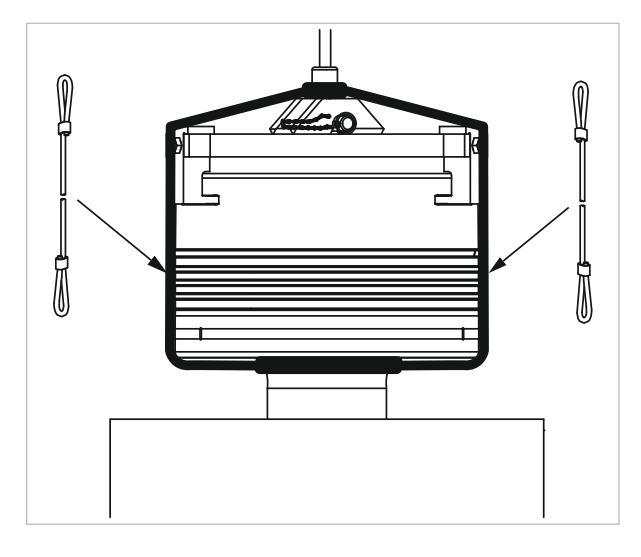
Fig. 2: Use textile rope slings for lifting operations

MAN Energy Solutions has updated the work card for piston overhaul. The update introduces two textile rope slings to be used during lifting operations. In the unlikely event that a breakage should occur, the slings will prevent the piston rod from dropping in an uncontrolled manner.

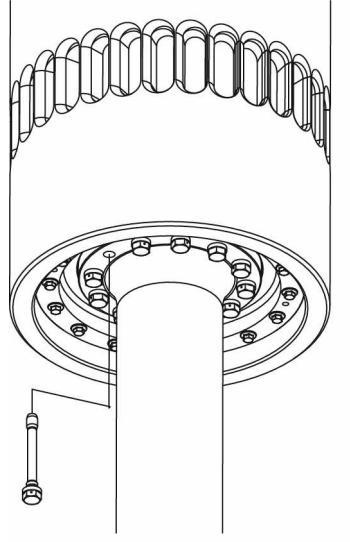
8865-4204-0001C04

. **NOTICE** The reference screw must only be screwed in BY HAND.The reference screw is a new piston crown screw or a screw removed from a spare piston, provided that the screw has not been in service

Screw a reference screw into the piston.

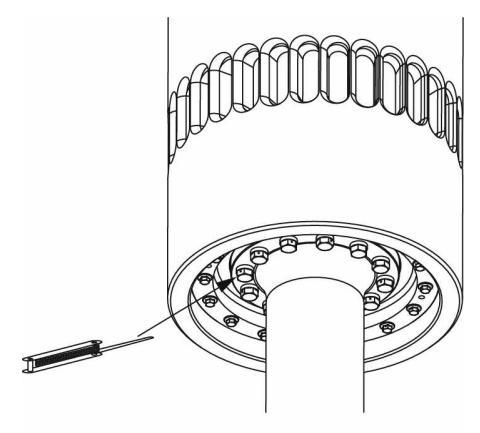
8865-4204-0001C07

If the screw shows signs of deformation or hard contact, as checked in step 5, OR if a gap is found between the reference screw and the piston rod flange, then the piston MUST be removed from the cylinder as described in the dismantling section of this S-instruction.

Using a 0.05 mm feeler blade check the full circumference of the contact face between the reference screw and the piston rod flange.

Subsequently the piston crown MUST be scrapped.
