L23/30 Service Experience

Proposals for safe and efficient running.

George Drossos
Marine New Sales and Promotion
6th June 2019

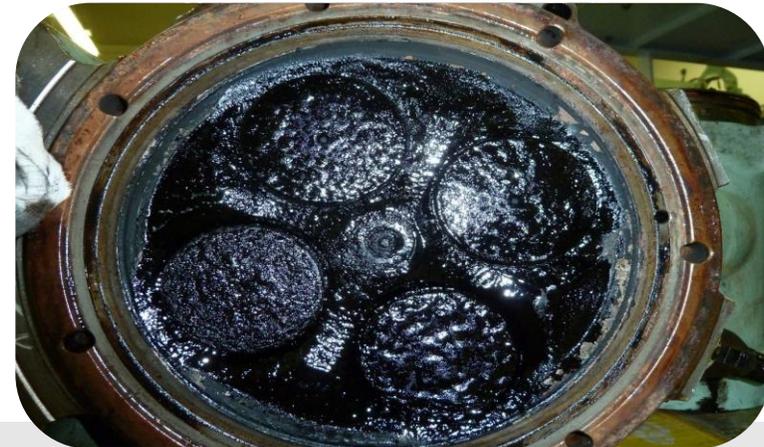
What is root cause?

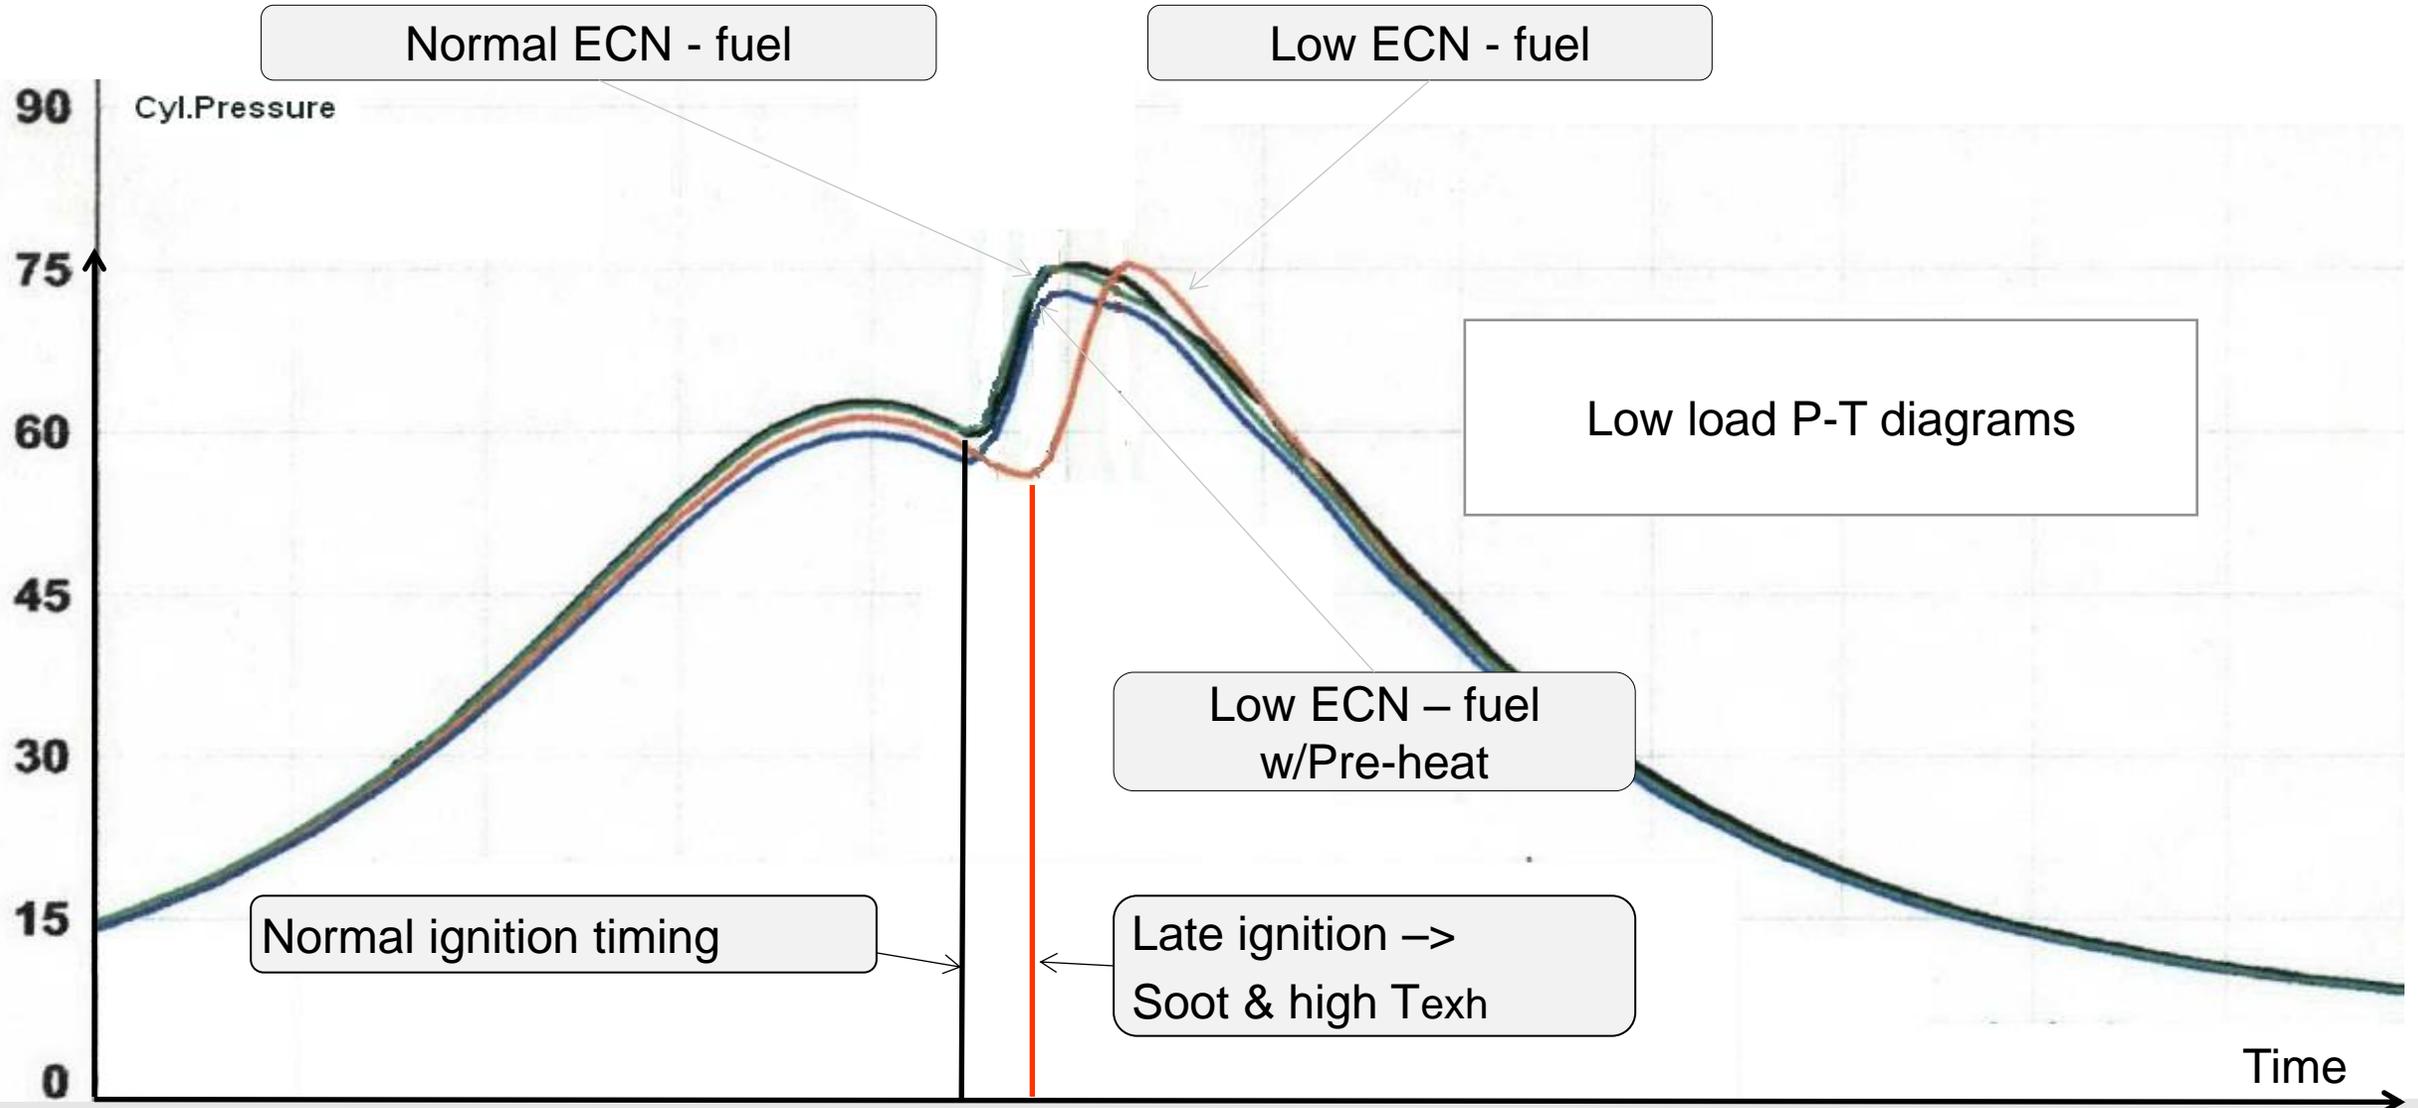
Ignition of Normal and Poor fuel – influence of preheat

The effect of low ECN-number

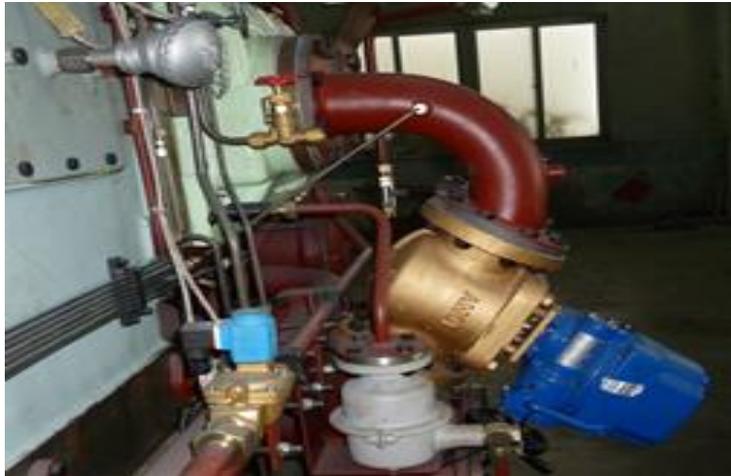
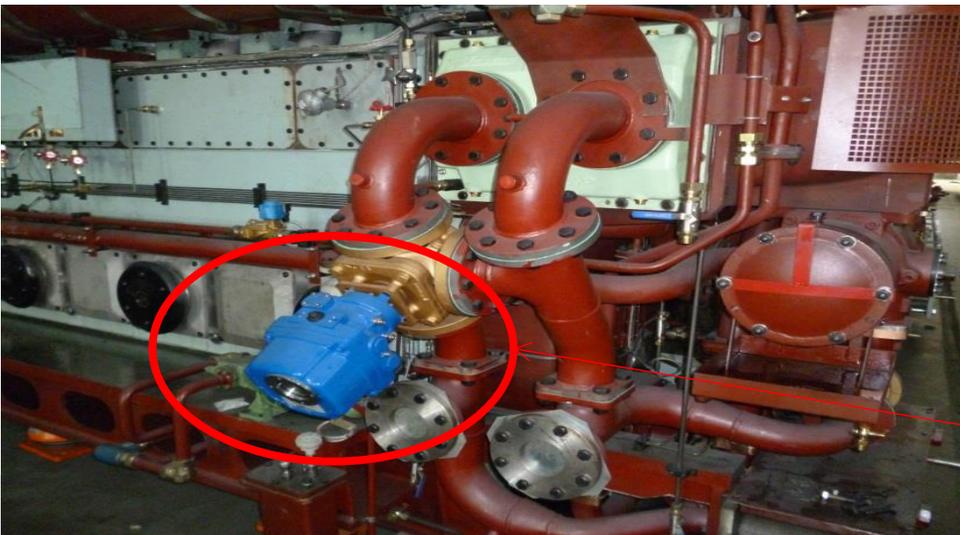
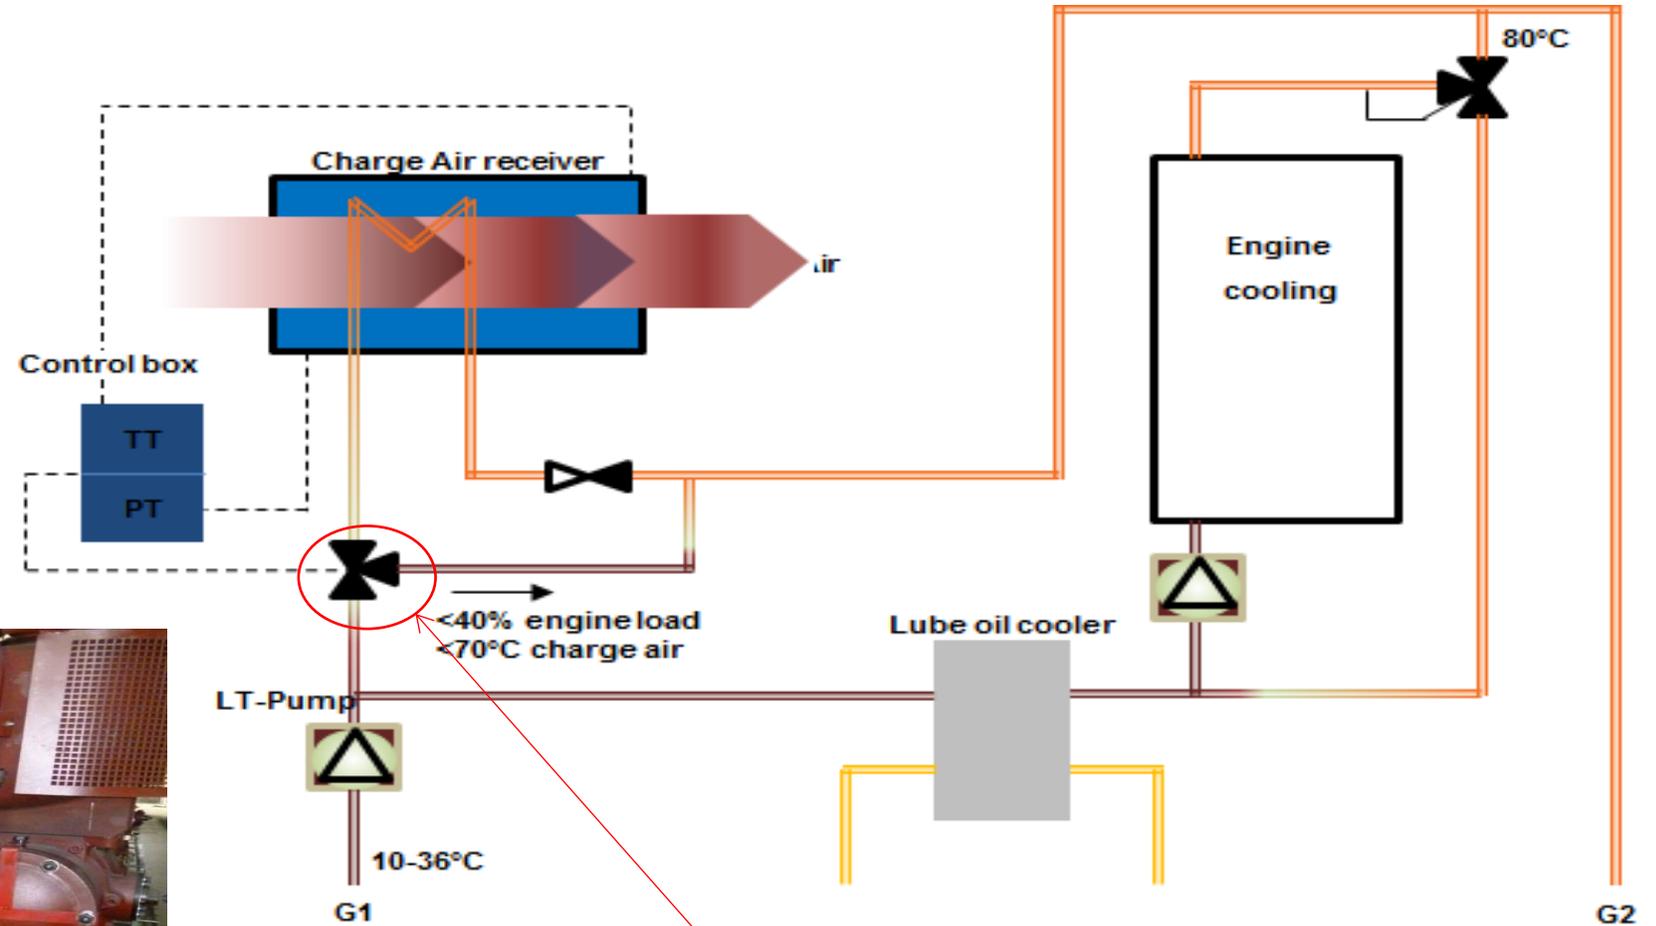
By-pass thermostatic valve

Preheat – necessary with poor fuel & low load

By-pass valve active at low load

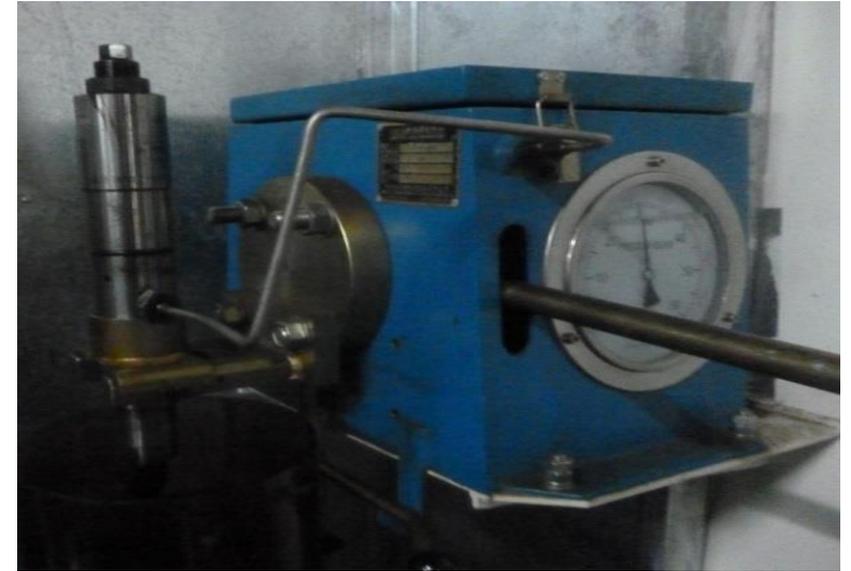
Fuel injector test device

Parameters which CAN be tested:

1. Test Pressure: Condition of nozzle seat
2. Spray: Are all nozzle holes free?
3. Tightness: No leakage (The drop)

Parameters which CAN NOT be tested:

1. Atomization during engine operation
2. Opening pressure during engine operation

Reason:

1. Test performed at 300 - 400 bar
2. Engine operates at 1100 -1600 bar

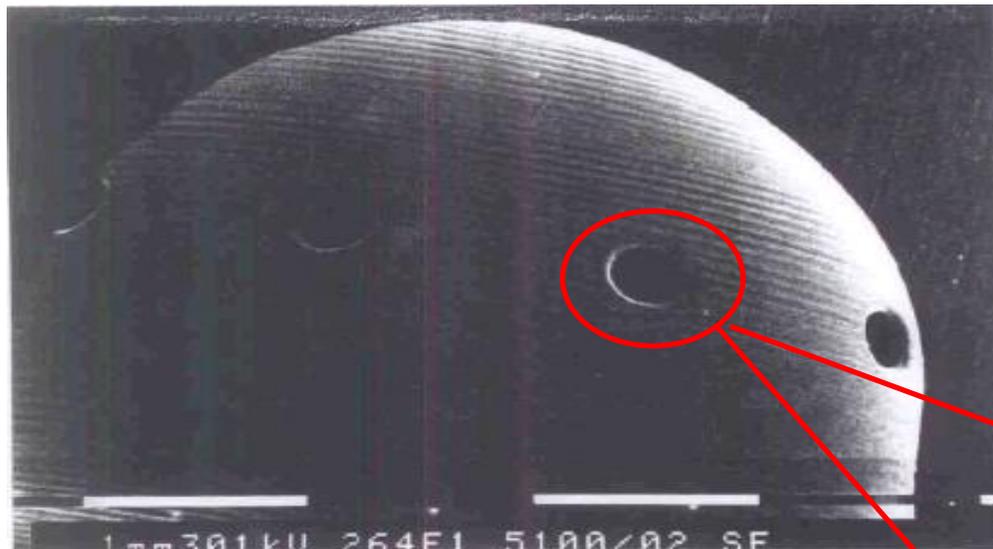
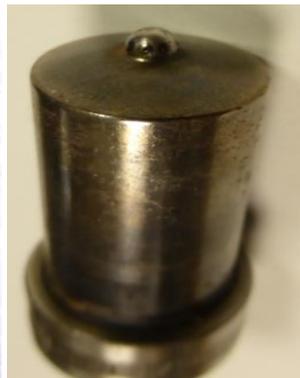
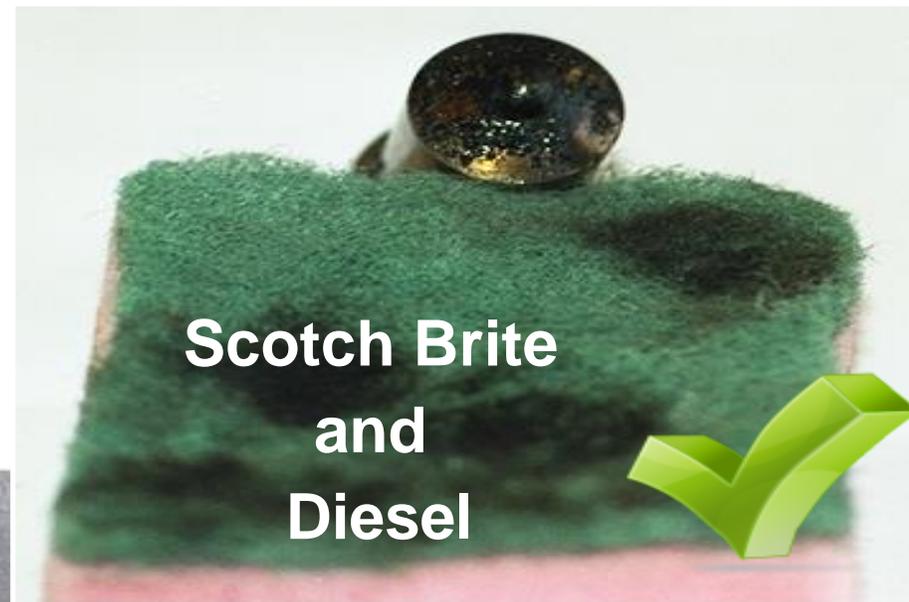
Fuel nozzle treatment

Warning! – severe damage to entire engine!

**Never use
Rotating steel brushes**

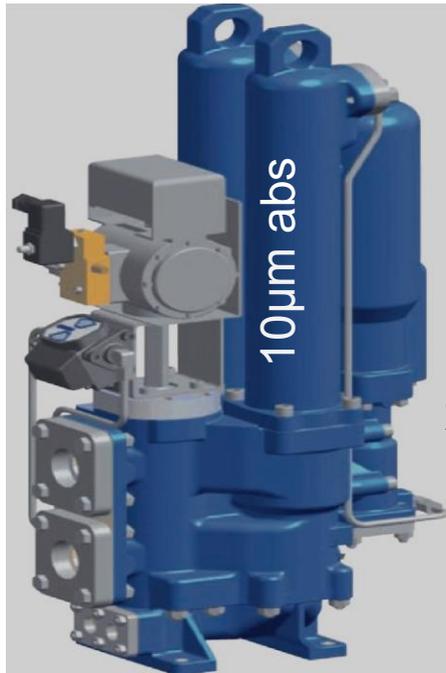
Cat-fines filter in Circulation loop

Uni-fuel system - 2 stroke ME & 4 stroke AE

- Repeated cleaning
- Synergy with Separator (1+1=3)
- Commission/overhaul (flushing)
- Generated in system (normal/damage)

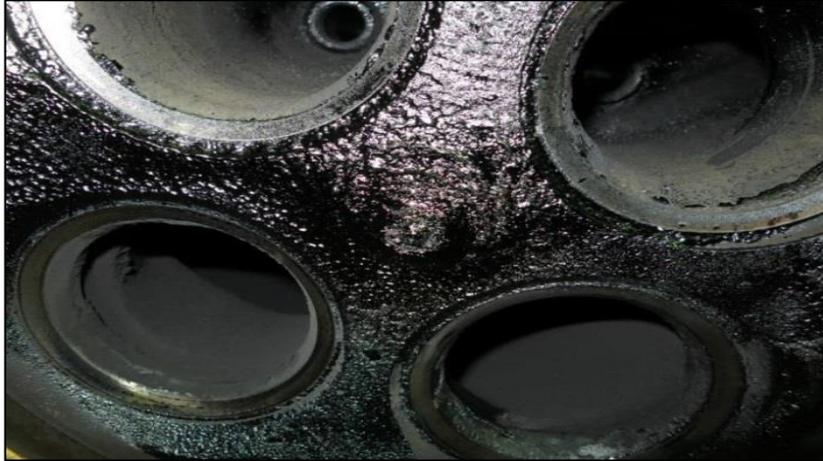
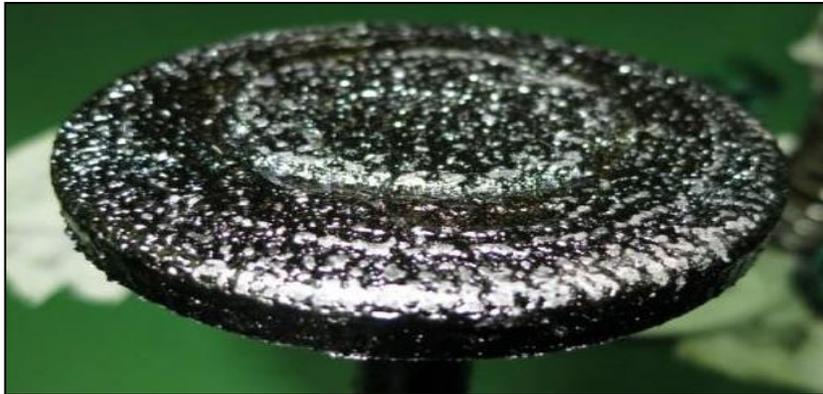
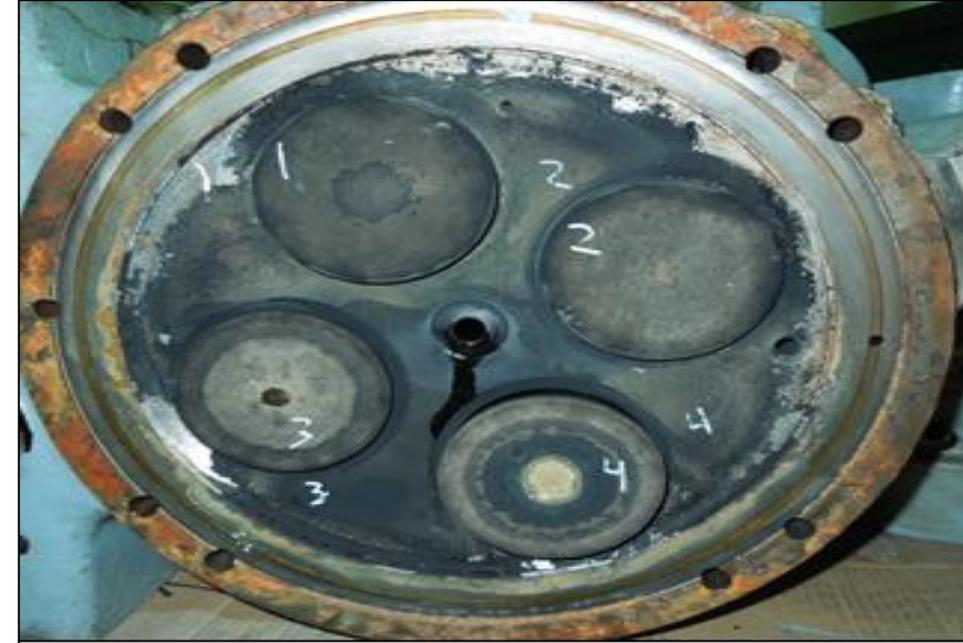
Case Study - Install 10µm Cat fines filter

In circulation loop

Before

10 µm abs

After

Clean combustion

- No particles
- No damage to nozzles
- No sticking fuel pumps (seizure)

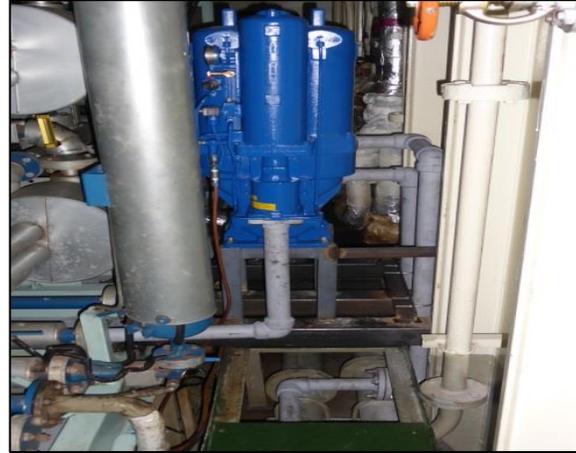
Filter

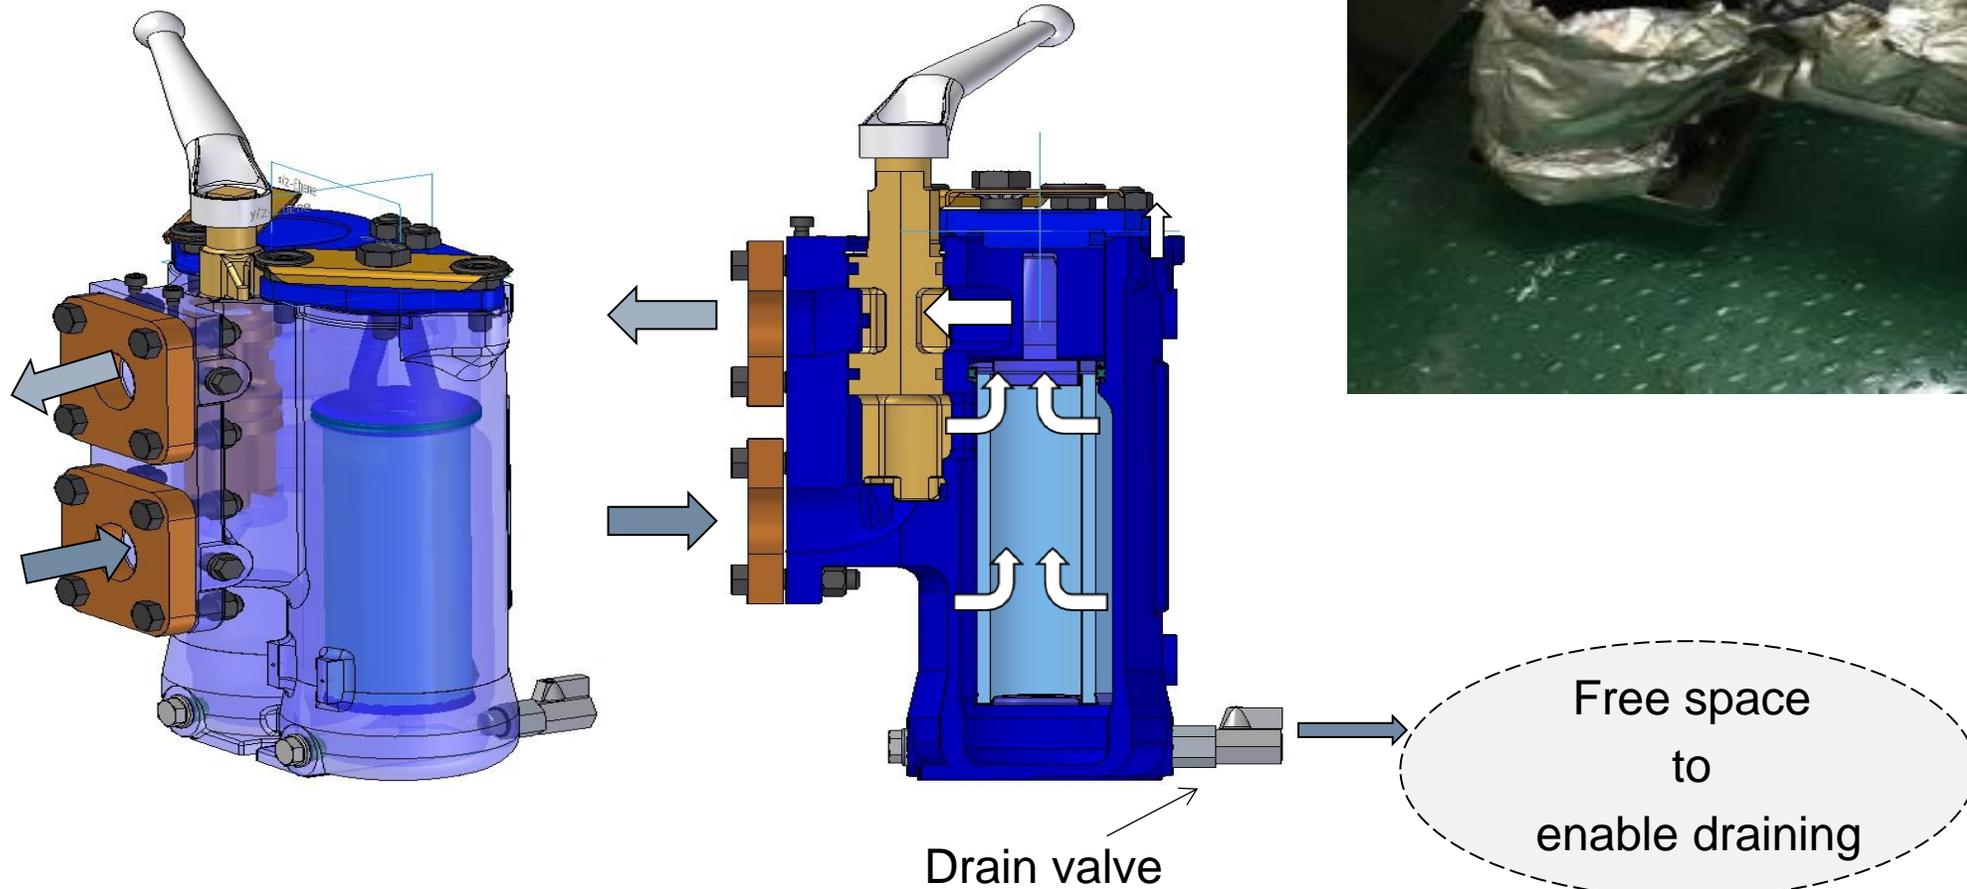
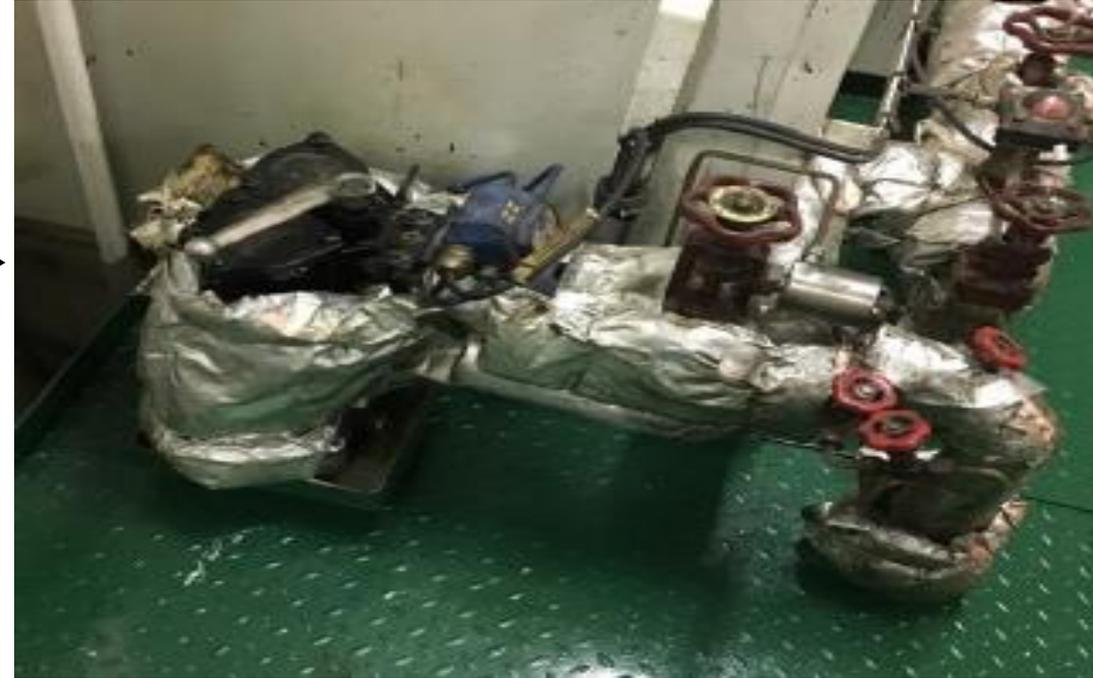
Fuel safety filter – Drain before lifting insert

25 µm abs

Is draining possible before cleaning?

See Service Letters
SL2017-640
SL2016-615
SL2014-595
SL2013-577

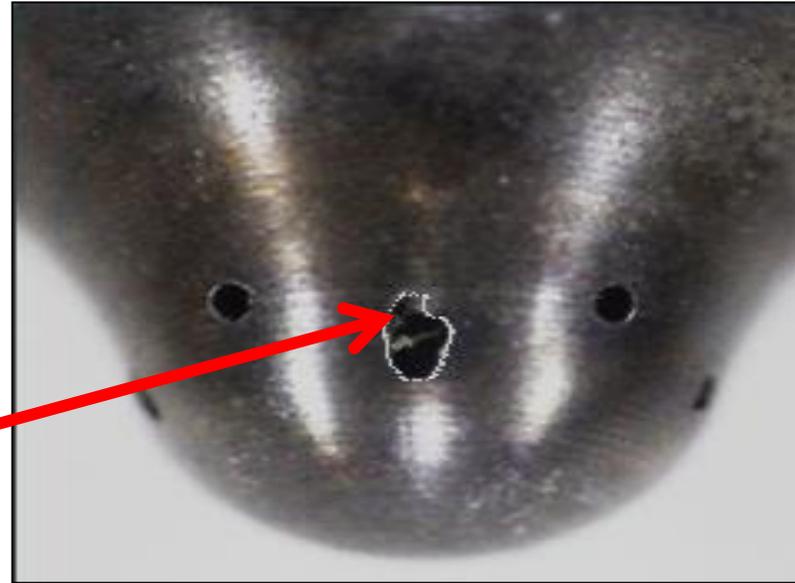
Damage from catfines particles in nozzle holes

Particles in fuel

- Damaged fuel nozzles
- Poor combustion

Damage due to abrasive particles
Causing poor spray

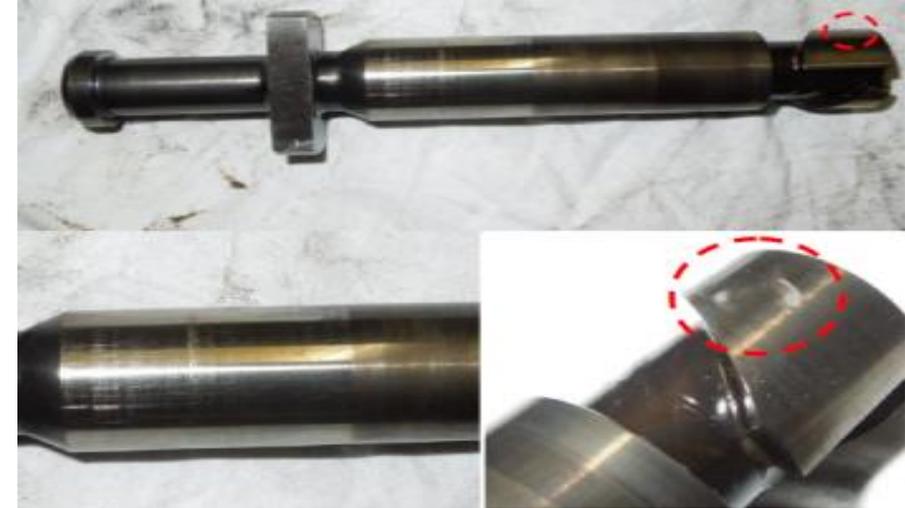
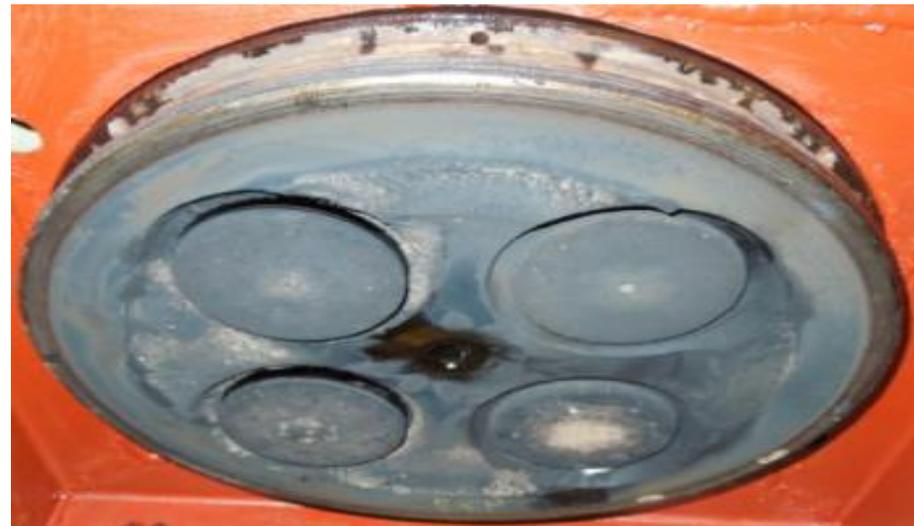
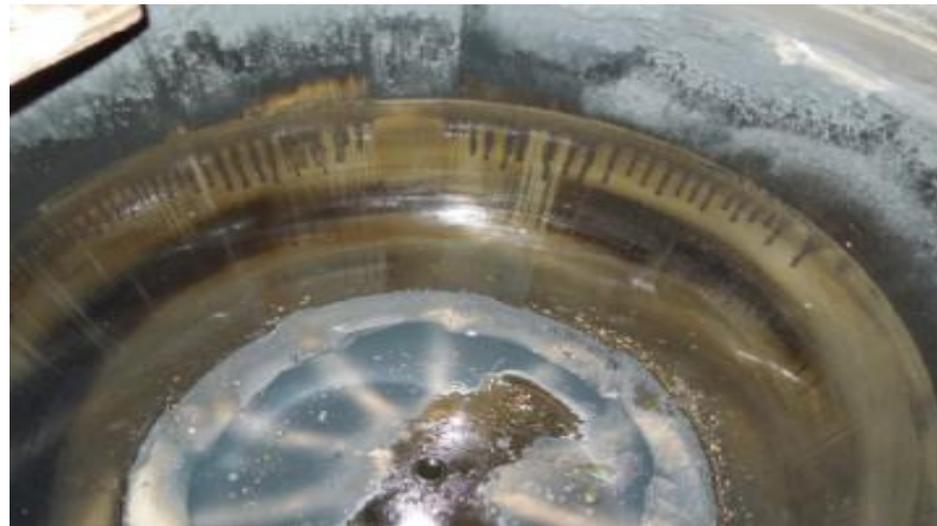
Inspection at 2225 hrs. Cyl. No. 1. Conclusion:

- All parts in good condition
- No abnormal or extra wear
- Some lacquer and coke deposits on liner and nozzle

Reason most likely:

- Low load operation
- Lube oil additives to be adjusted to ULSFO

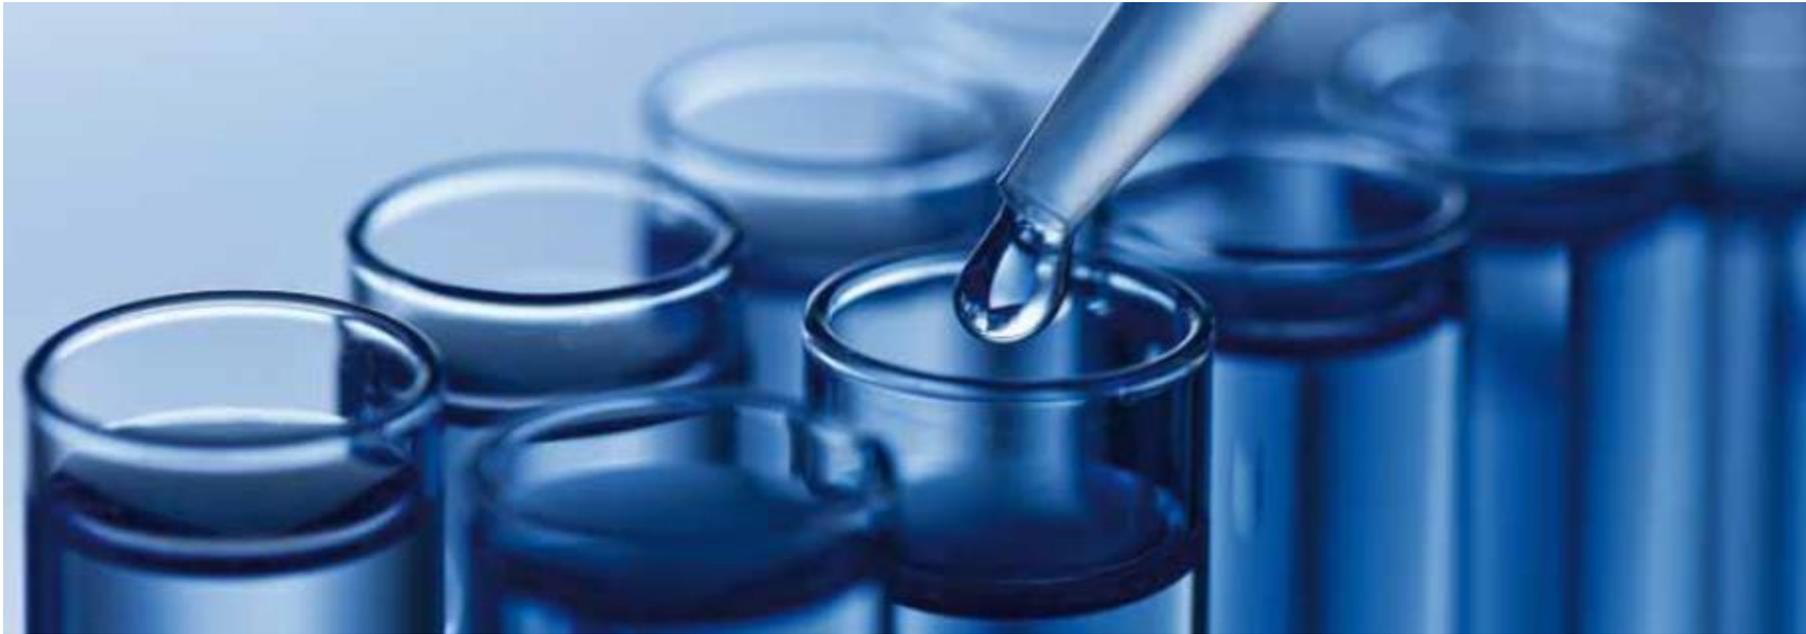
Lube Oil Contamination

A result of...

➔ **Fuel Equipment – *producing* contaminant**
Combustion efficiency, Fuel Quality, Fuel Nozzles, Mechanical condition

➔ **Cylinder unit – *protecting* contaminants way to Lube Oil**
Piston rings, Cylinder liners

➔ **Lube oil cleaning – *Removing* contaminants**
Separator, filters

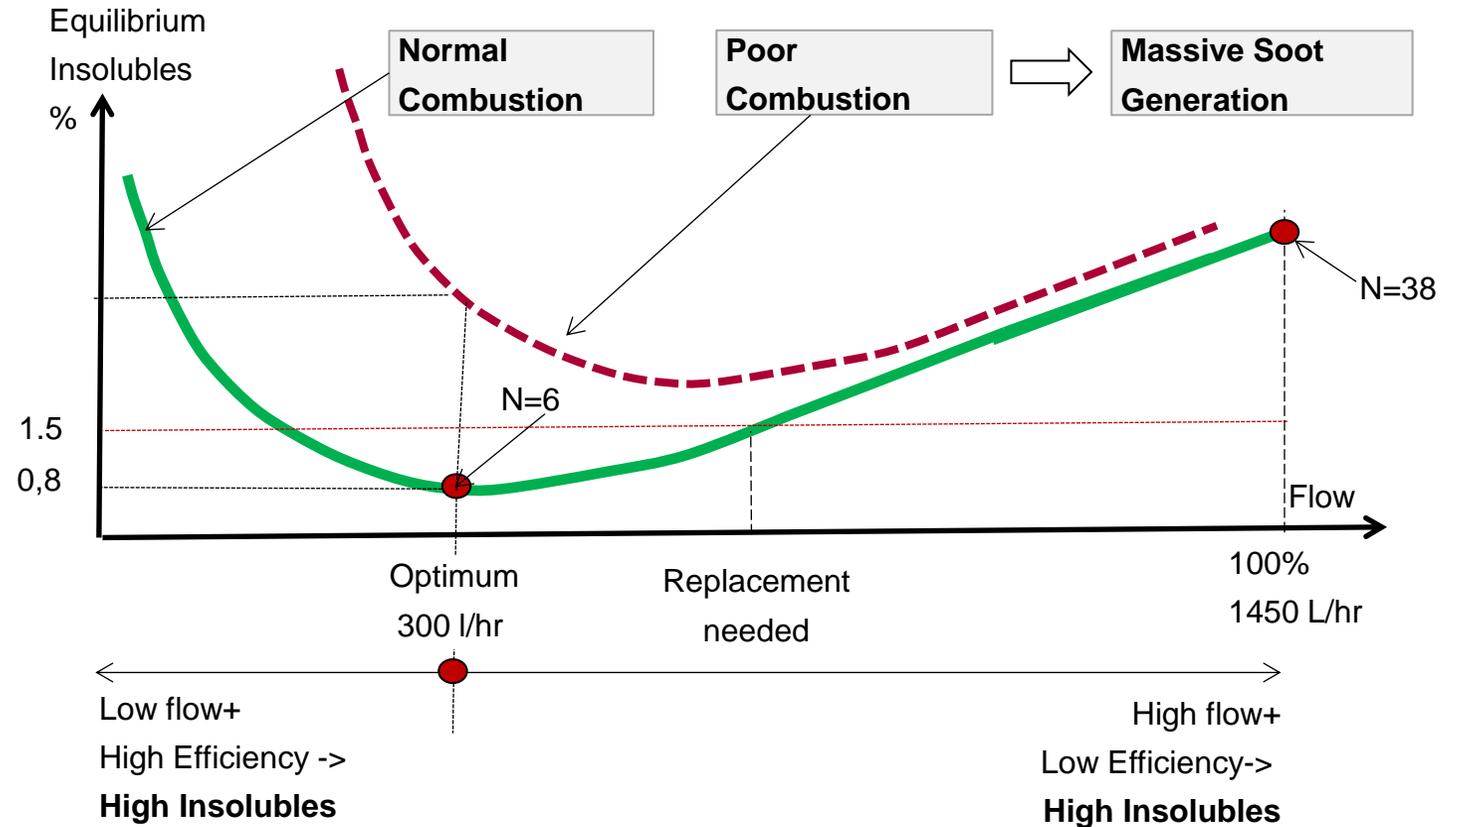
$$Q = \frac{P \times 1.36 \times n}{t}$$

Example

Genset 660 kW -> 229 l/hr

3 gensets, average 1.3 running: 229 x 1.3 = 300 l/hr

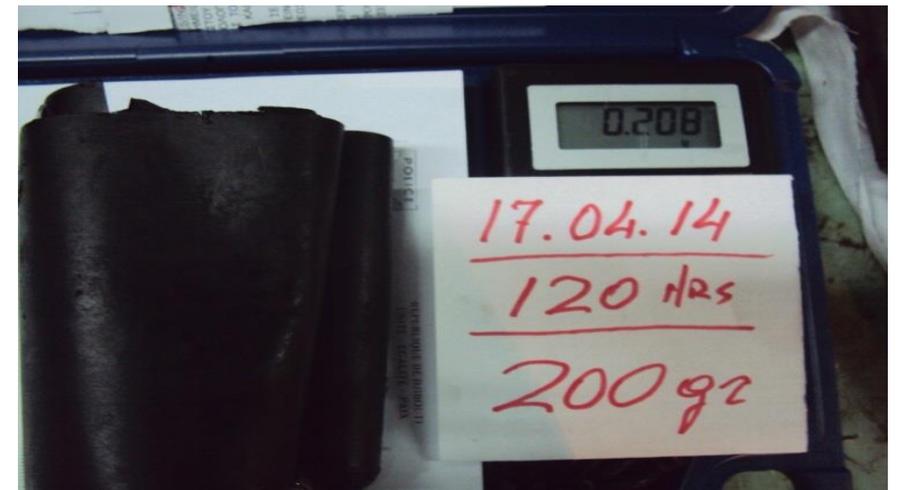
Factor 10

Reduced flow: 195 l/hr
200g/100 hrs

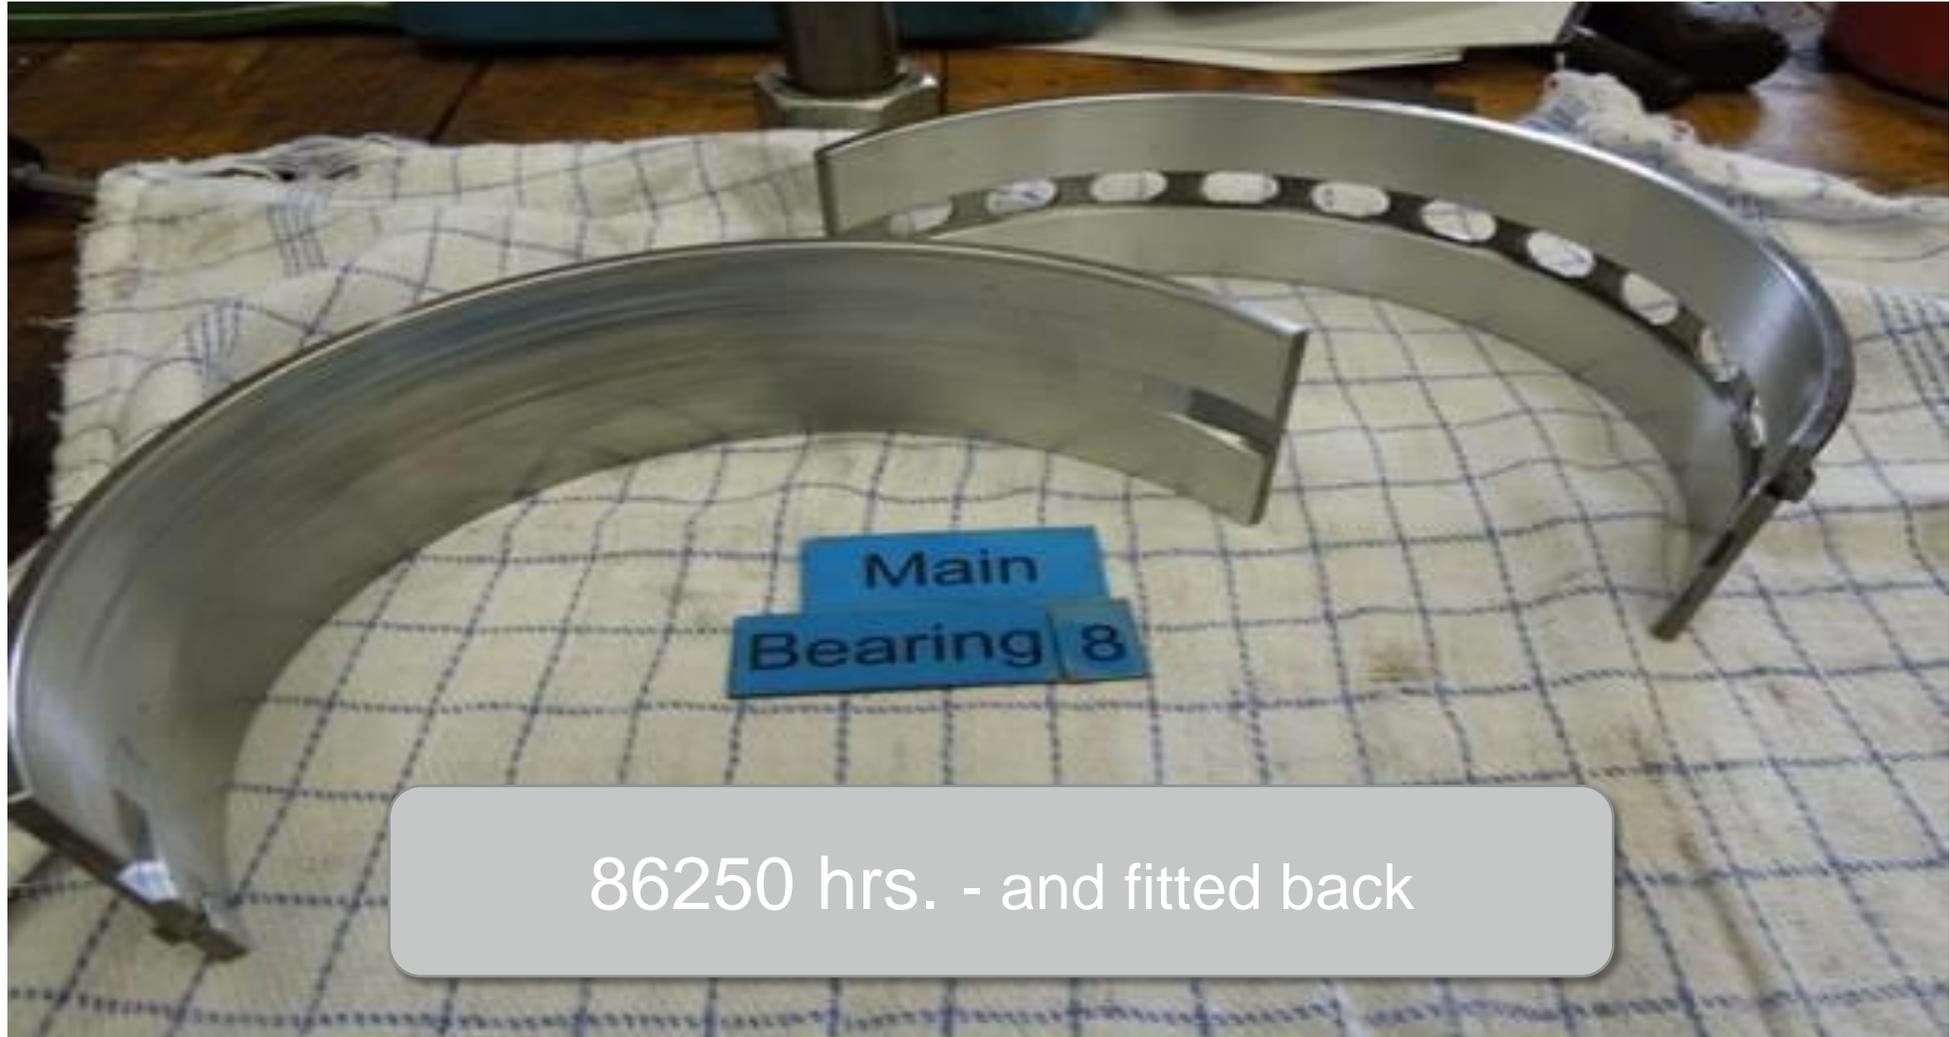
L16/24 Main Bearing

Lube Oil – Result of clean lube oil

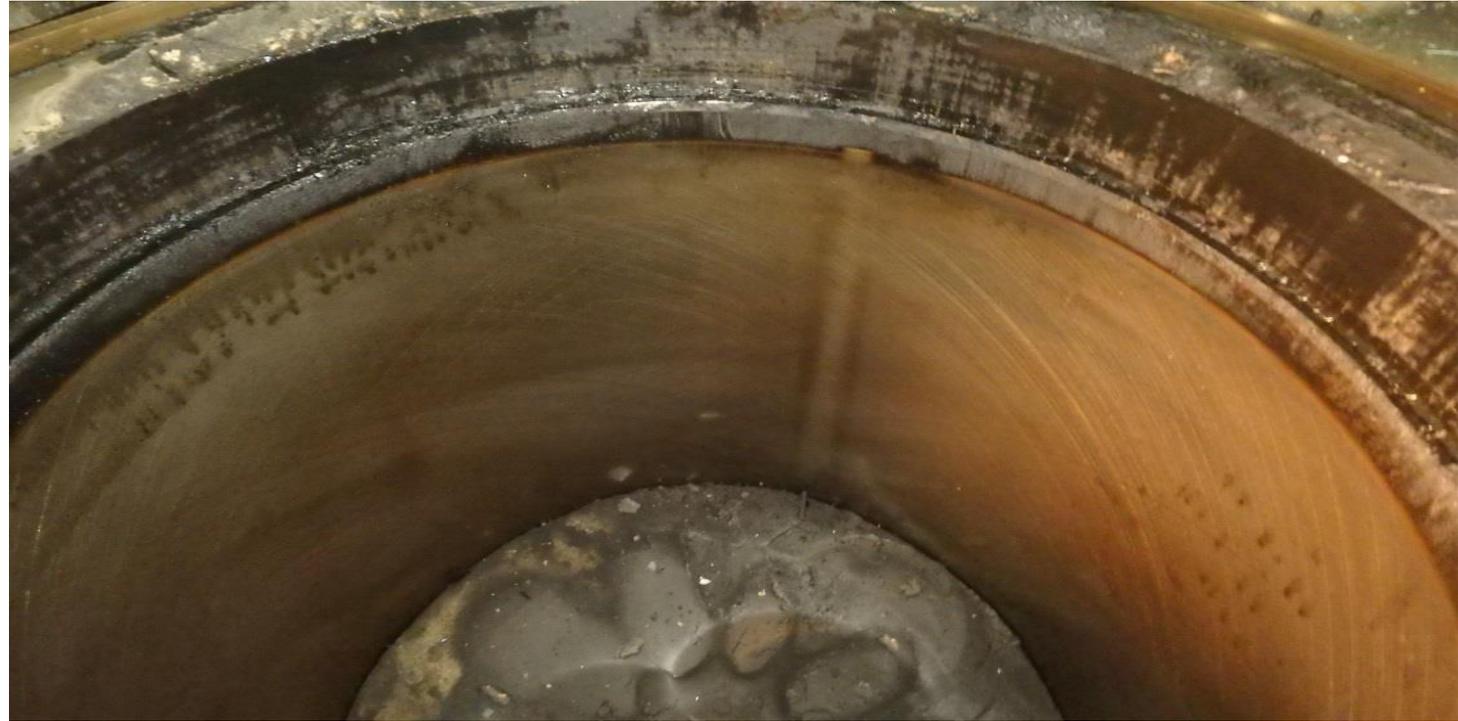
Cylinder liner lacquering

Results

Engines operated on LSMDO/MGO or switching between HFO and LSMDO/LSMGO

New 3rd ring. Lube oil consumption 4-8 litres pr. Day.

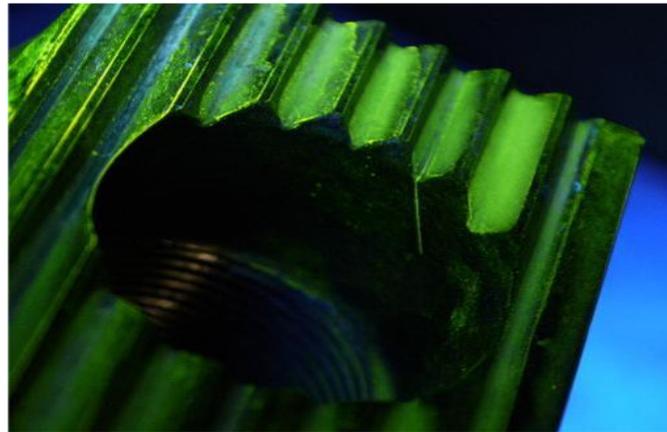
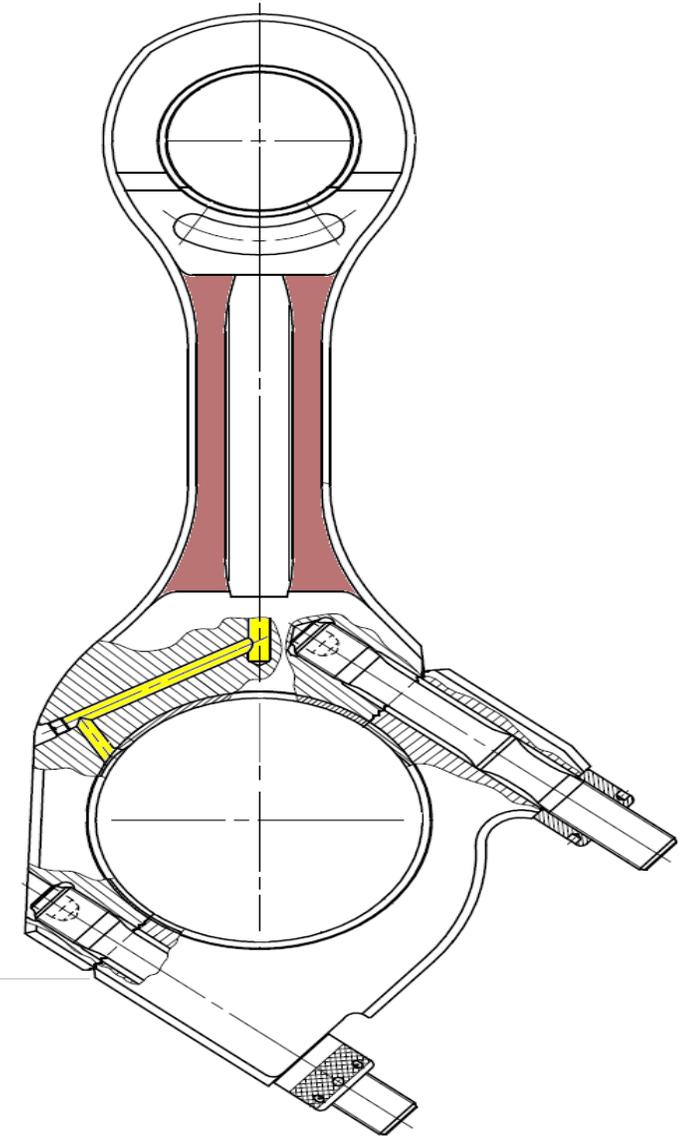
L23/30H Connecting Rod – Assembly face

Correct machined and assembled connecting rods:
3 main overhauls -> 36.000 – 48.000 operating hours.

Re-toothing possible 2-3 times

First Overhaul:

High ovality and/or cracks in serration
-> incorrect machining from maker

Following Overhauls

High ovality and/or cracks in serration
-> failure during last assembly

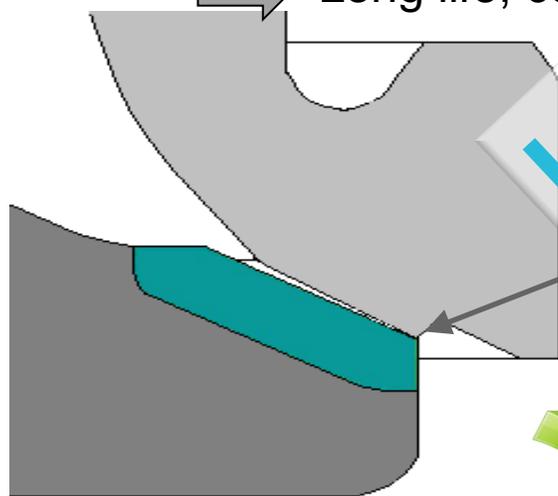
Correct seat Angel

- Inner gap closes
- Full contact
- Good cooling
- Long life, cone and seat

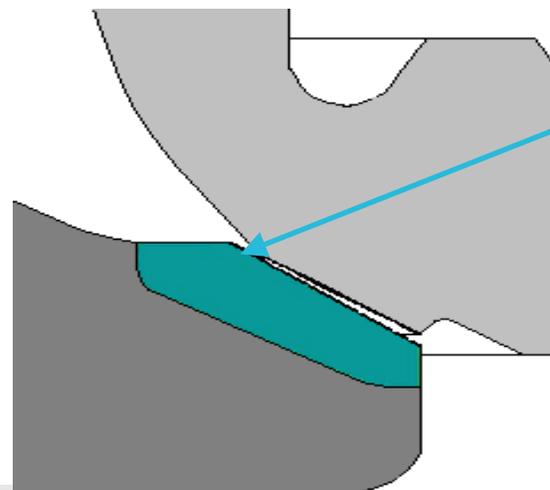
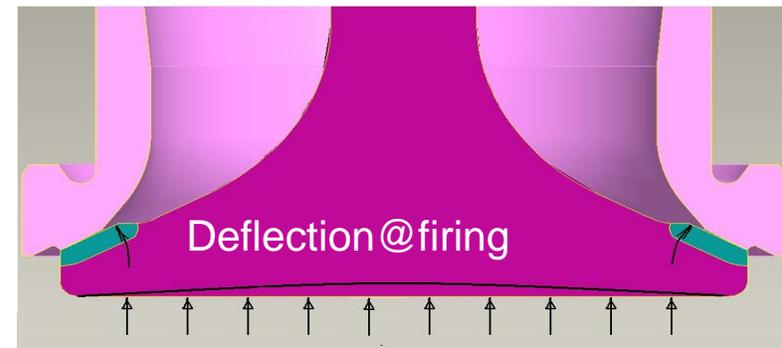
Wrong Seat Angle

- Outer gab increase
- Deposits on seat
- Insufficient cooling
- Burned cones, dented seats

Lapping is not allowed
