L23/30 Service Experience

Proposals for safe and efficient running.

George Drossos
Marine New Sales and Promotion
6th June 2019

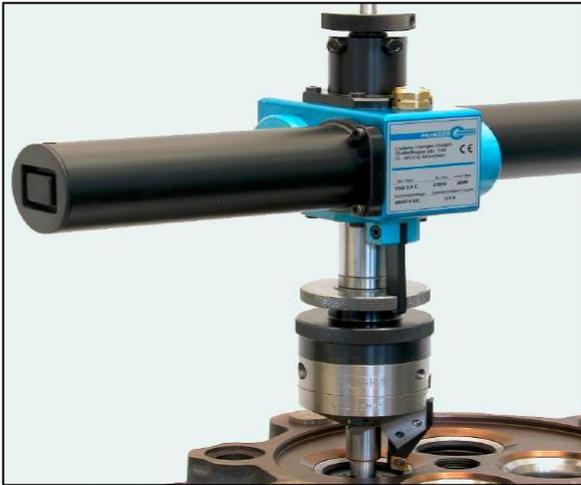
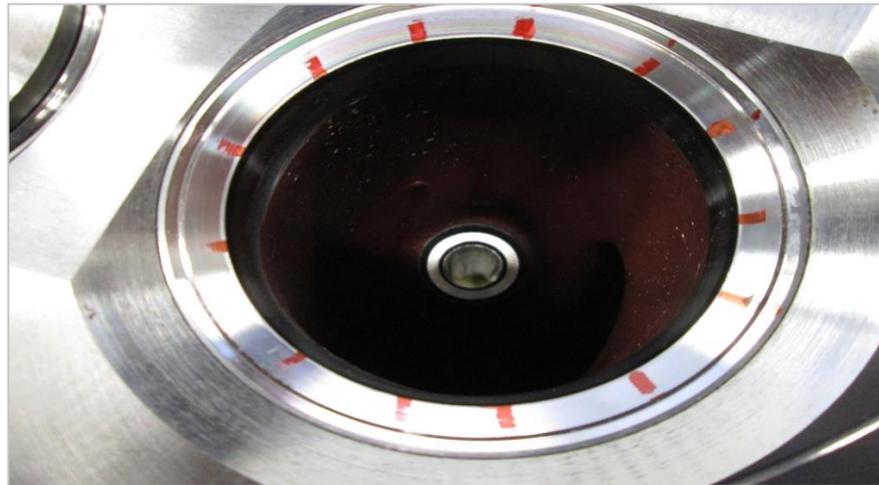
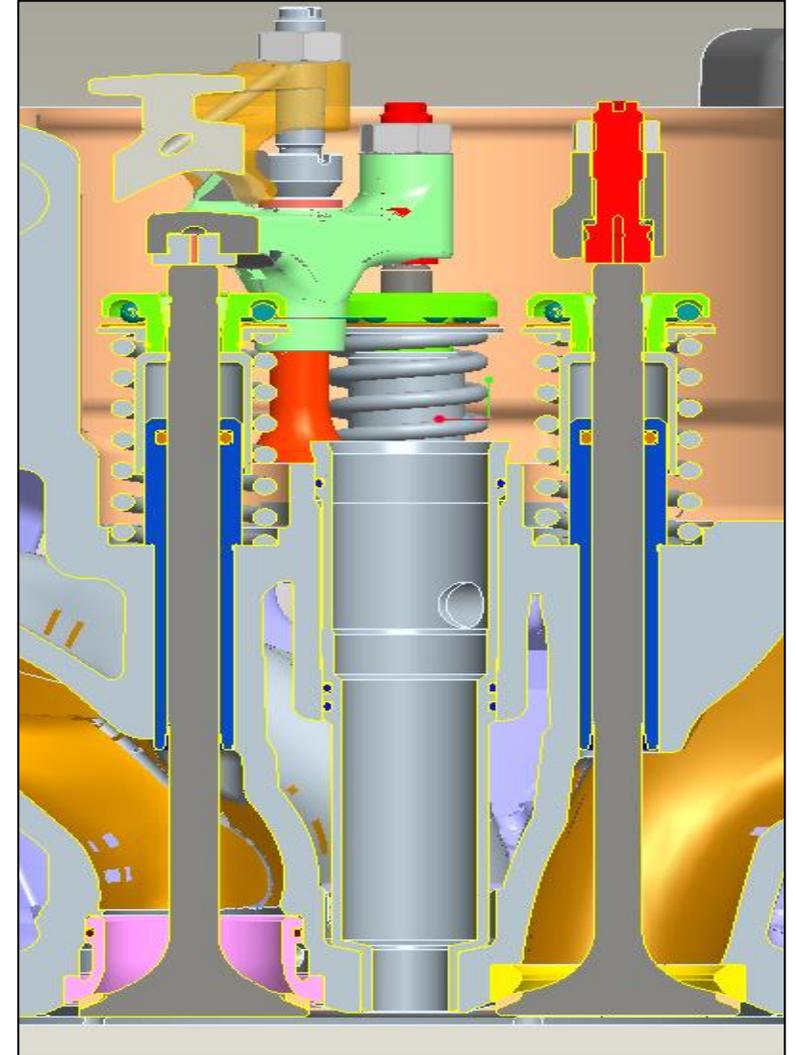
Overhaul of top cover

1. New valve guide Mounted carefully by cooling (nitrogen)
2. Seat rings mounted carefully by cooling (freezer)
3. Valve guides MUST be reamed after mounting
4. Valve seat MUST be machined by 'Hunger' or 'Chris Marine'
5. Spindle/seat contact MUST be checked with colour paste

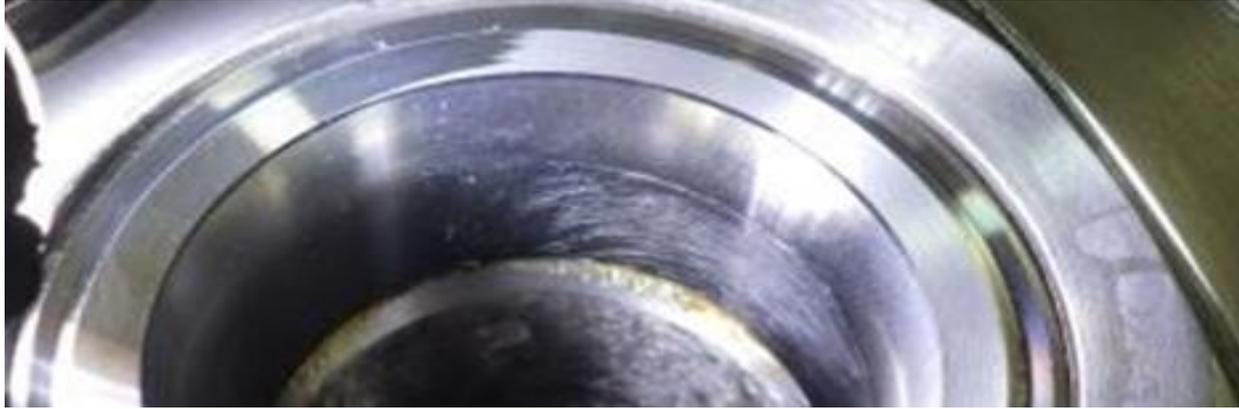
Replacement of Valve Seat and guide

Valve seat MUST be machined after replacement of Valve guide and/or Seat ring to ensure good contact

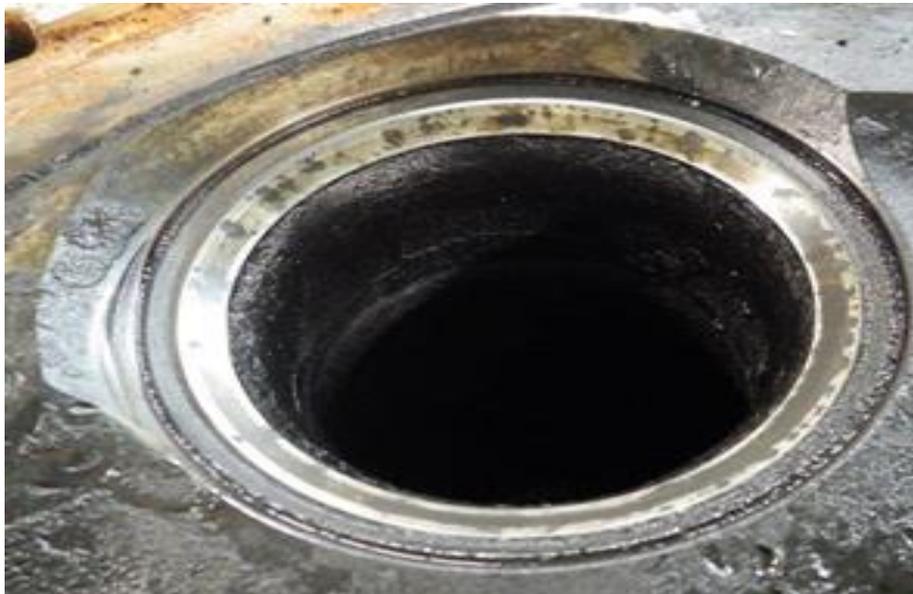
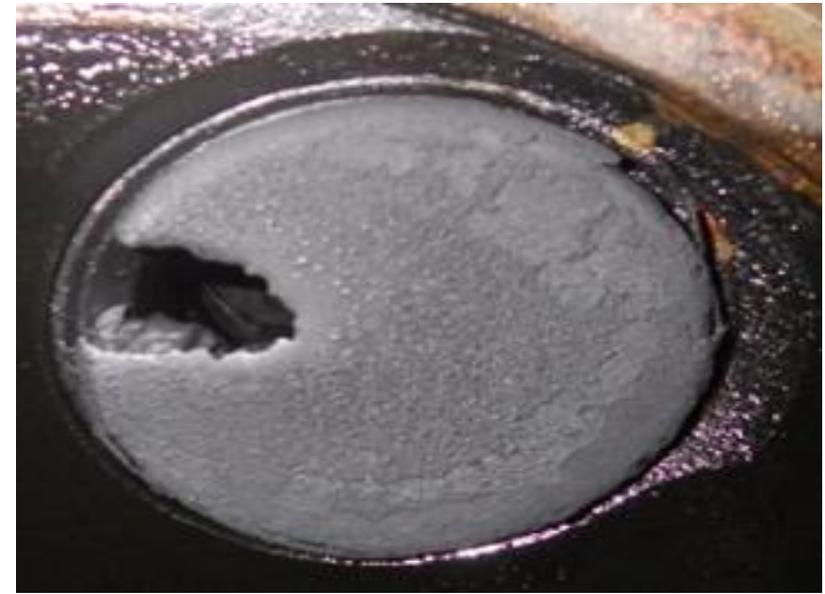
No machining

Poor contact

Burned valves

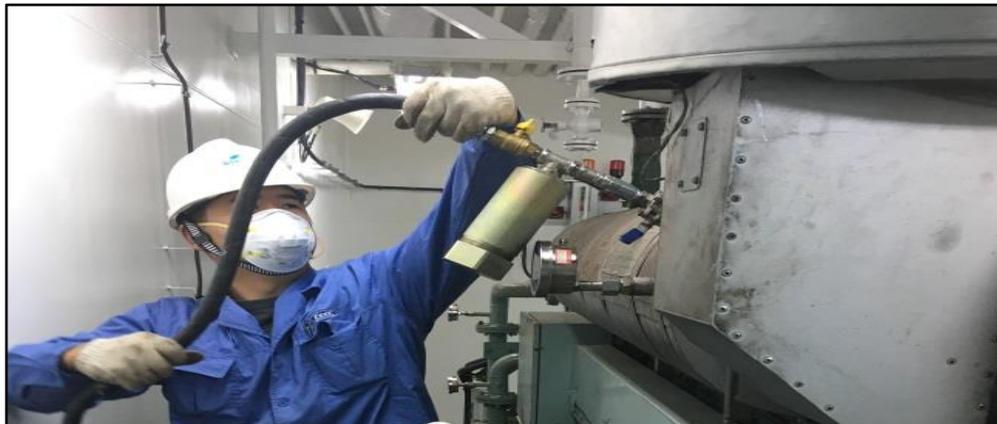
Tool
Wet cleaning

Daily: Dry cleaning
Weekly: Wet cleaning

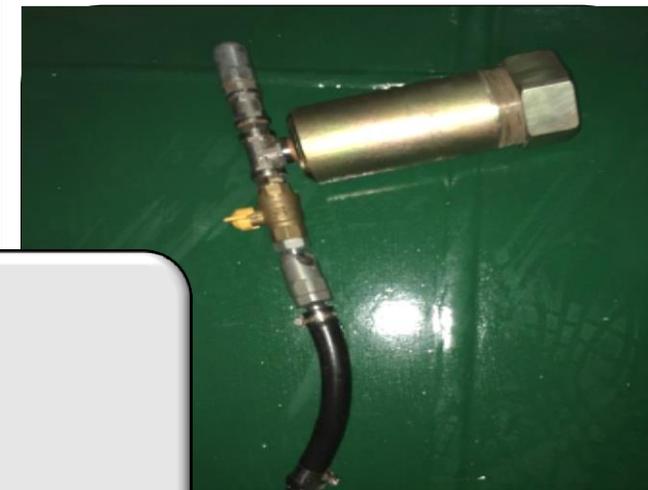
Tool
Dry cleaning

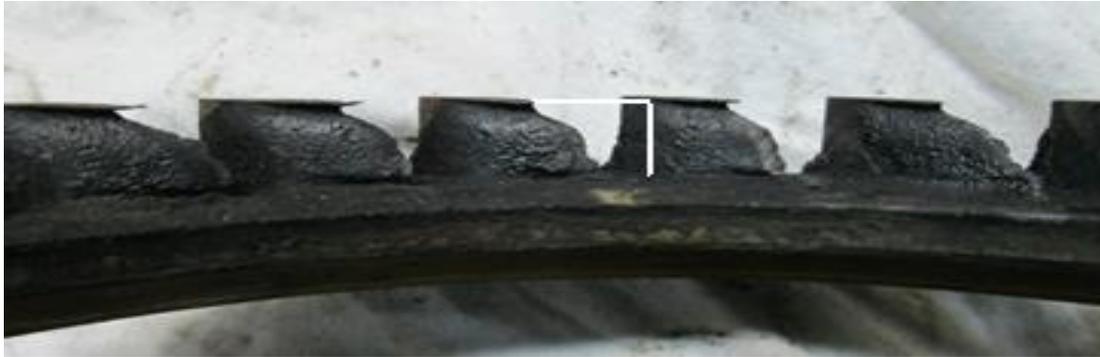
Nozzle ring – NR12/S

2,000 running hours
No cleaning of TC,
neither water nor dry

Worn out

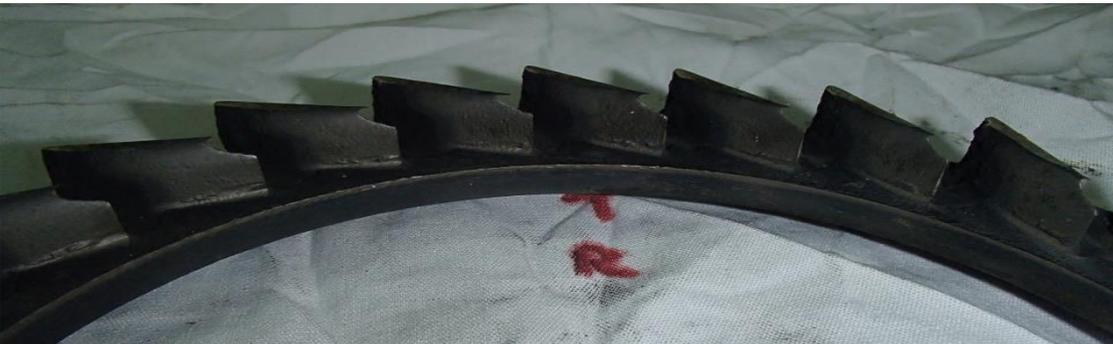
9,000 running hours
Daily dry cleaning
Weekly water washing
Surface-coated nozzle ring
Good fuel treatment

Expected lifetime
16,000+ hrs.
