Service experience

MAN Energy Solutions

MAN B&W two-stroke engines

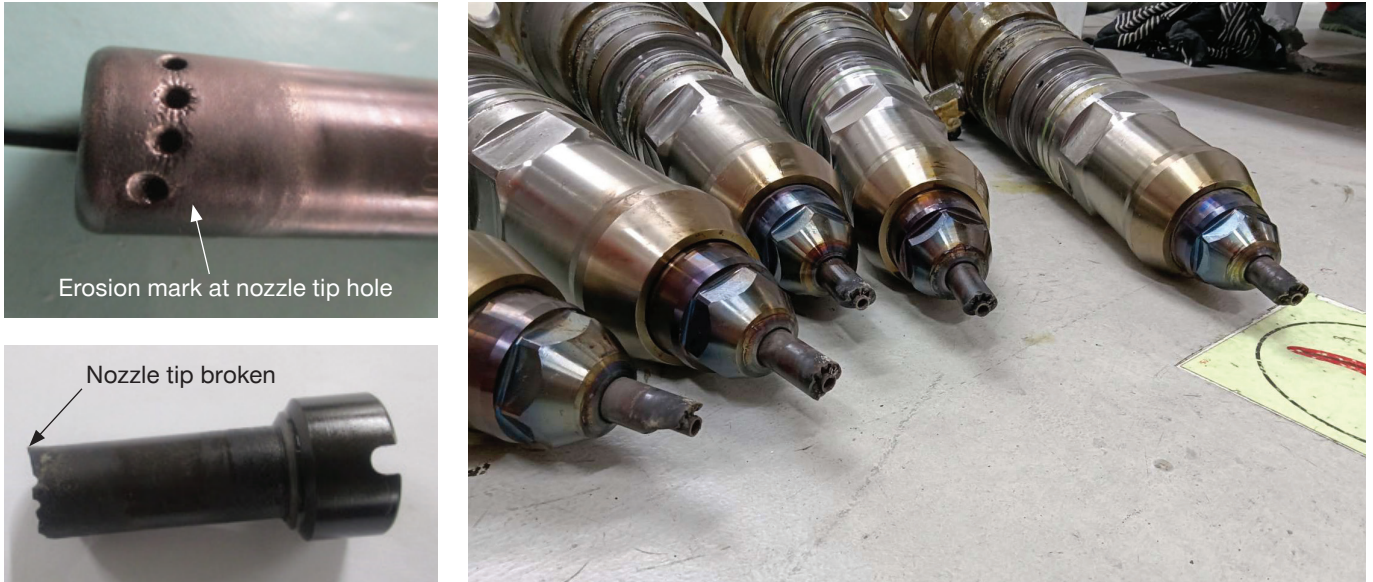
Fig. 8: Nozzle failure after a period of Tier III operation with water addition

However, in Tier III mode, the third generation of 50-bore LGIM (LGIM-W) engines uses either water emulsified in fuel or water in methanol to achieve Tier III compliance. The much longer injection periods used in this operating mode give rise to increased thermal fatigue stress on the nozzles, and examples of cracks are seen. Fig. 8 shows a case where five nozzles broke more or less at the same time after a

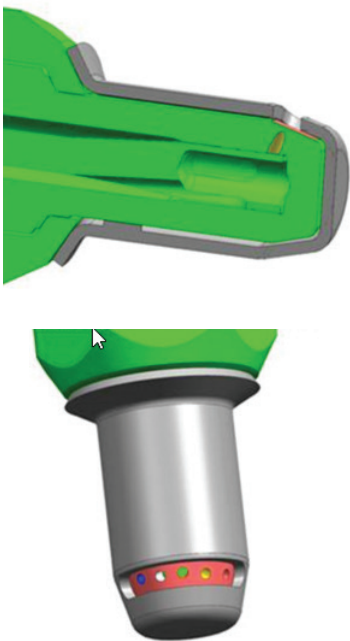
Fig. 9: LGIM gas nozzle with heat shield for G95-LGIM engines

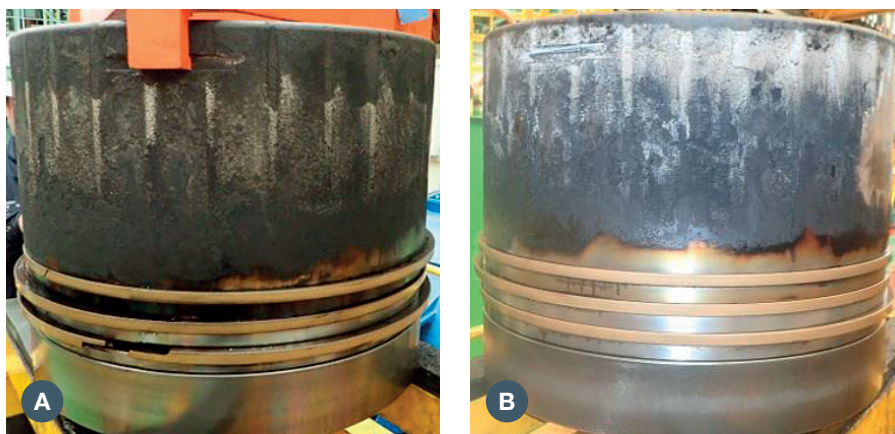
Fig. 14: Condition after test bed when A. using a low-BN cylinder oil, B. using a 70-BN cylinder oil. Notice the difference in the piston ring land cleanliness.

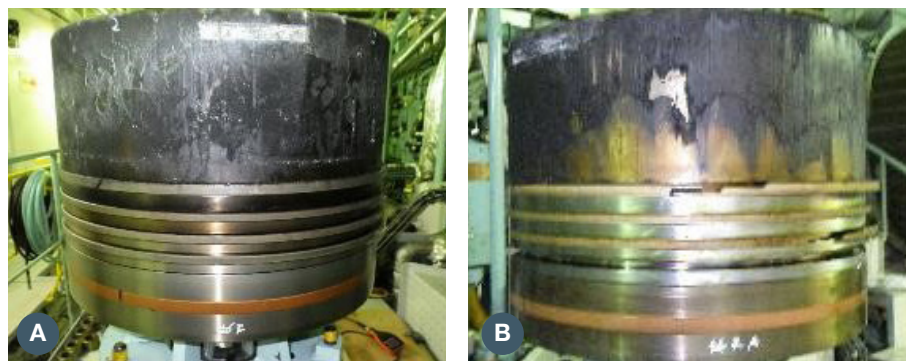
Fig. 15: Comparison between A. a four-ring pack and B. a three-ring pack on an ME-GI engine. The cleanliness is improved by changing the ring pack.

To improve the cylinder condition and cleanliness, and also improve the margin against scuffing, MAN Energy Solutions introduced the controlled pressure relief (CPR) three-ring pack. The rings are all coated with a cermet coating that provides a more seizure-resistant surface against the liner.

The rings are designed with gastight finger locks on all three rings. The gas leakage is managed by the controlled leakage (CL) grooves on the two upper rings, whereas the third ring is gastight. Thereby, the gas leakage is reduced to a minimum. Another major benefit of this design is that the leakage through the piston rings is not affected by cylinder liner or piston ring wear. The pressure distribution is thus kept constant throughout the entire service life of the components.

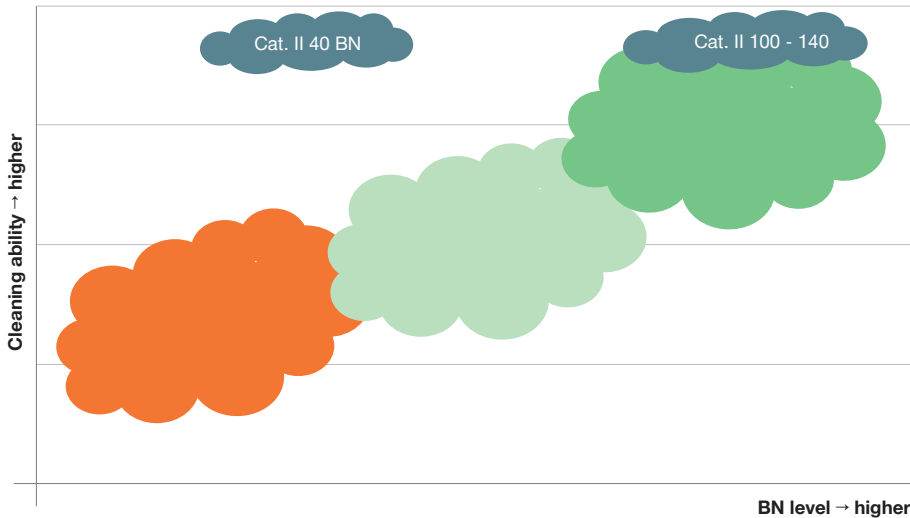
Fig. 16: Schematic representation of the perceived relationship between BN level and cleanliness and the new category II 40-BN, 100-BN, and 140-BN lubricants

Over the years, it has been found that the ability to keep the engine clean seemed to be coupled to the BN level in the lubricant, see Fig. 16.

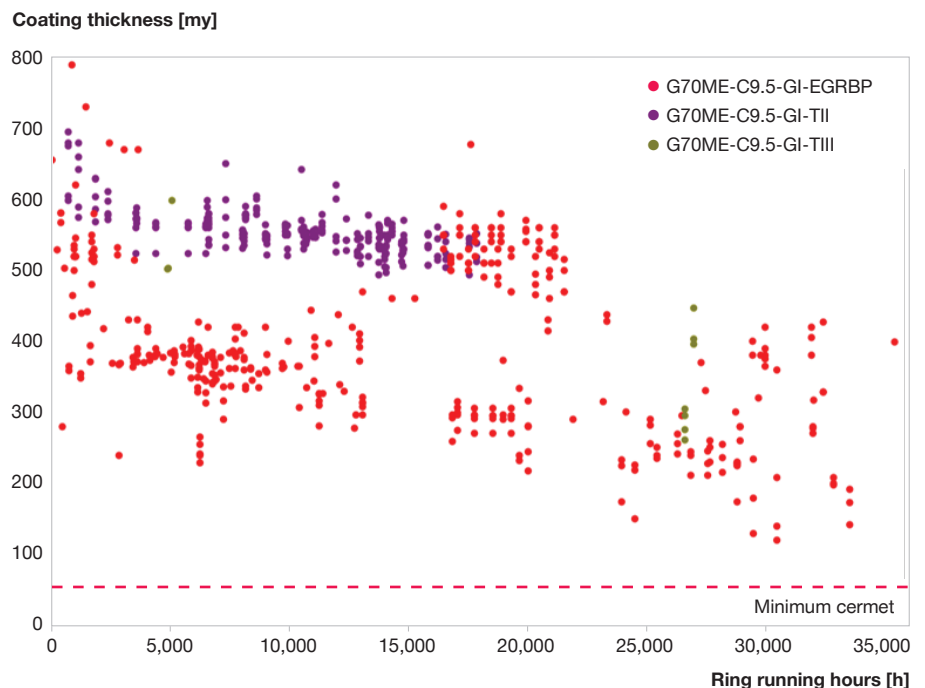
Fig. 17: Cermet coating thickness on the first piston ring. Data points from measurements on nine vessels (data from 90 cylinder units) during five years in service (G70ME-C9.5-GI).

Fig. 17 shows a plot of cermet coating wear on the first ring of multiple G70ME-C9.5-GI engines. It shows a positive overall trend, where wear progresses slowly. For all engines, the

wear trend indicates that wear-out will occur after 33,000 running hours, which is usually after five years.

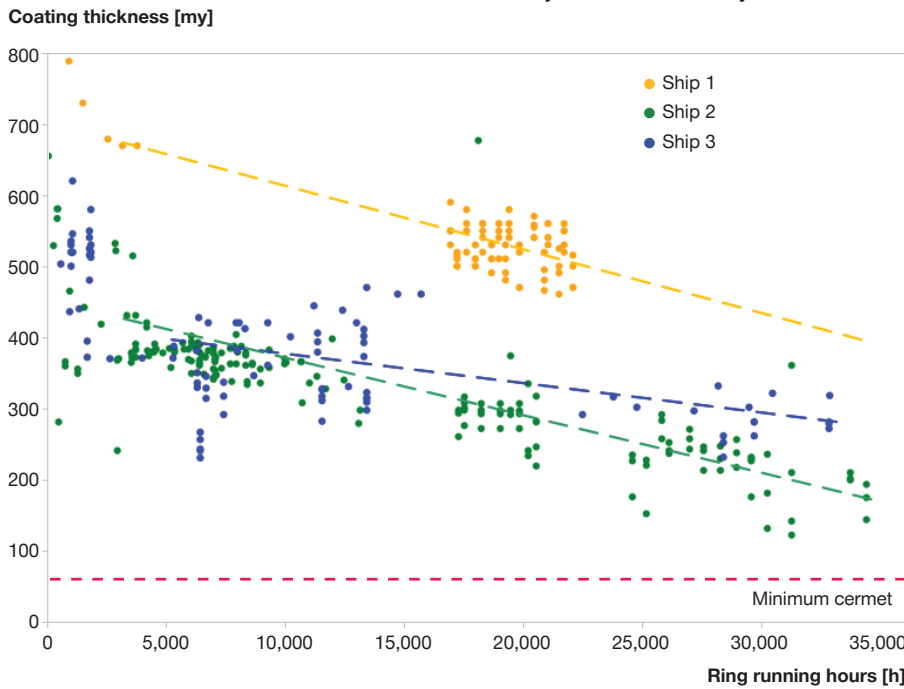
Fig. 18 shows cermet coating thickness on the first piston ring as measured during scavenge port inspections. The three series of measurements from each vessel (two engines each) represent ten cylinders of similar design. The x-axis shows the time range: 0–35,000 running hours, and the figure illustrates these data.

Ships 2 and 3, with most running hours, started using HSFO as pilot fuel and as main fuel when not operating on LNG in dual-fuel mode. As a consequence, wear was observed. However, after the 0.5% S cap came into force, the pilot fuel was changed to 0.5% S or lower. The wear rate change can be observed, and the rings installed later in service also showed improved wear potential.

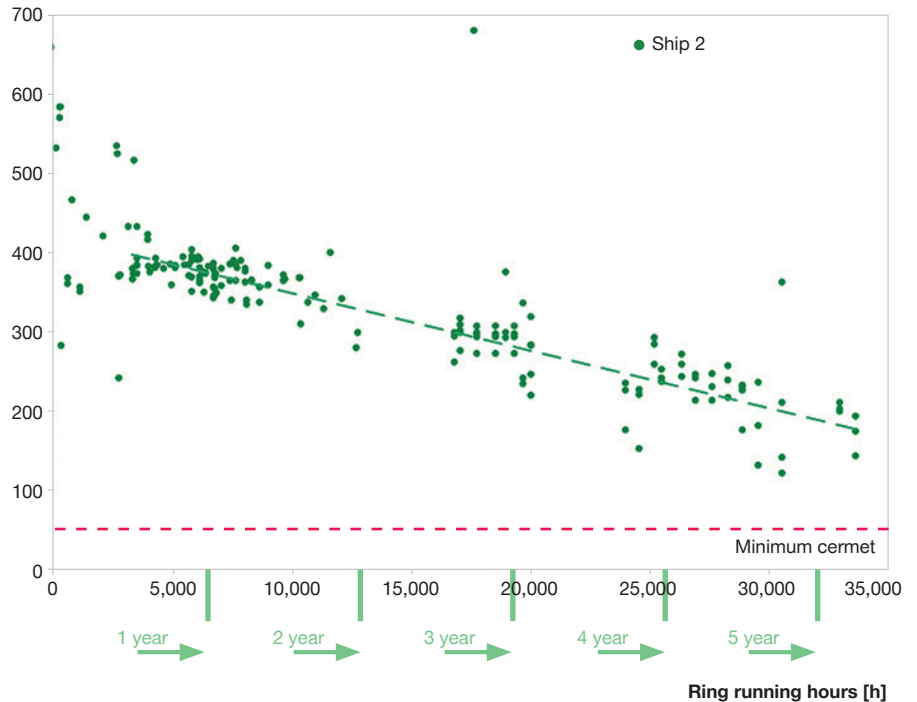
Fig. 21: First ring wear-down for Ship 2 during 35,000 running hours (G70ME-C9.5-GI)

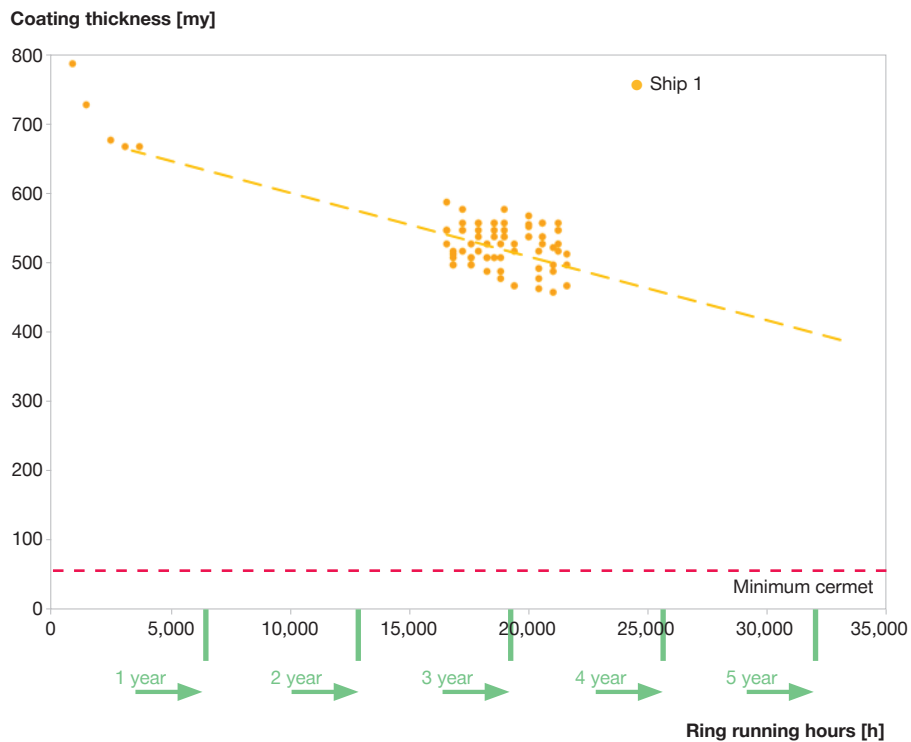
Fig. 22: First ring wear-down for Ship 1 during 20,000 running hours

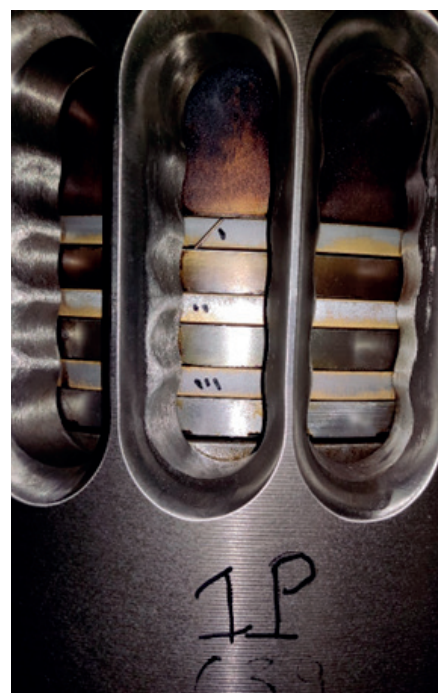
Fig. 25: Cylinder condition after 8,000 running hours – remaining running-in coating is yellow (G70ME-C10.5-GI)

The alu-coating is the running-in coating sprayed on top of the cermet coating, intended to be worn off after 1,000–1,200 running hours. The piston rings shown in Fig. 25 have been in service for around 8,000 running hours

and the running-in coating remains, indicating a very low wear rate.

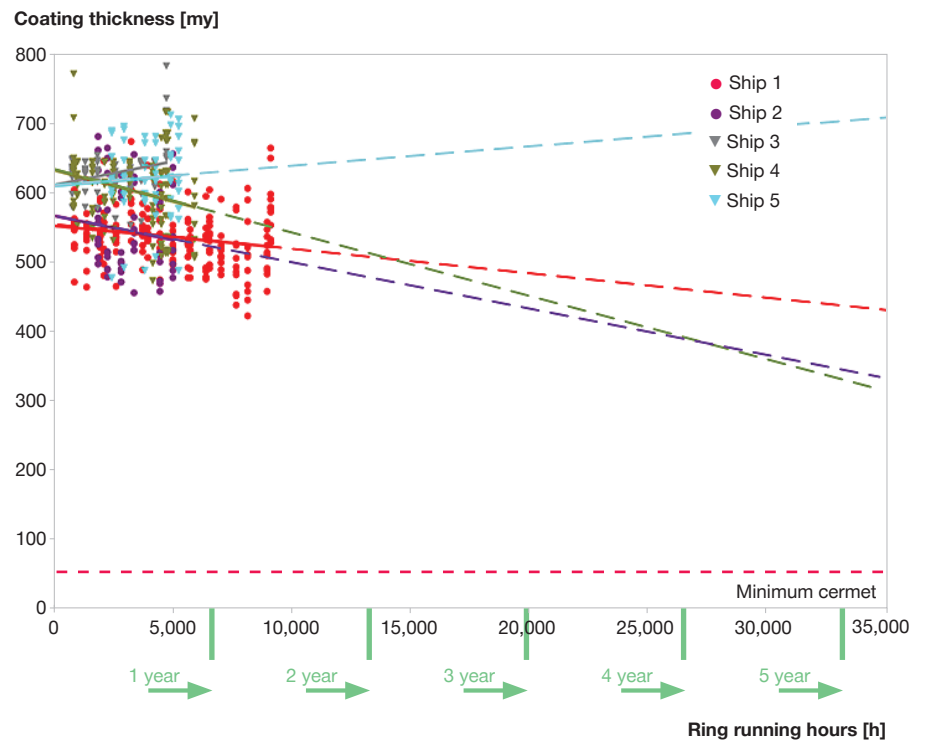
Fig. 28: Estimated progression of the wear rate up to 35,000 running hours (G90ME-C10.5-GI)

Fig. 28 gives an estimate of the wear to come, indicating that the ring wear-down will not happen until after the 5-year docking, potentially, lasting far beyond five years.

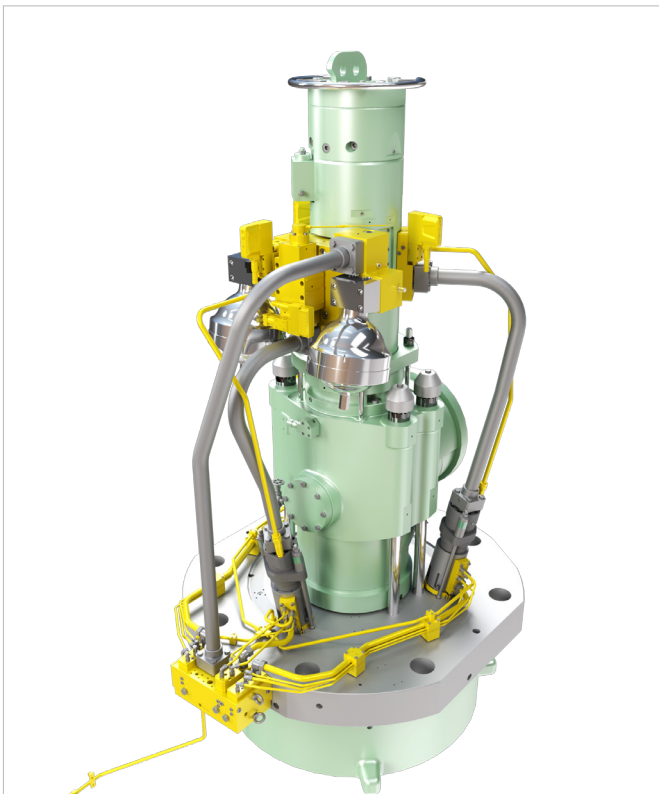
Fig. 30: Sequential injection system with integrated top-controlled exhaust valve

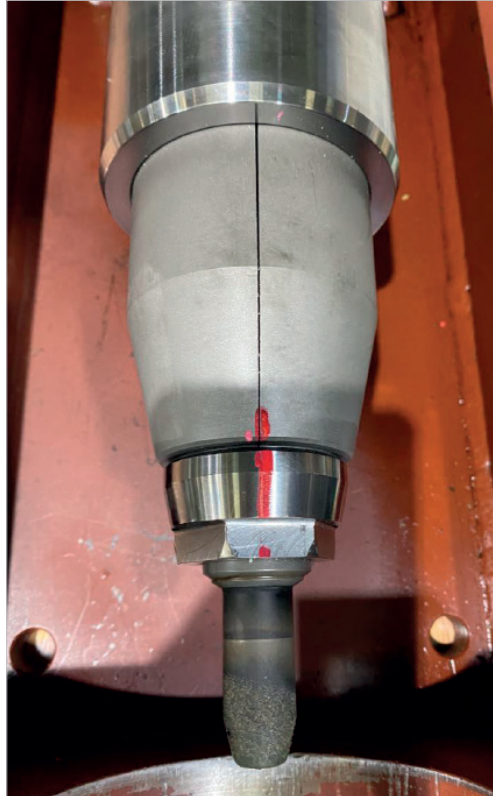
Fig. 34: FBIVS spindle guide failure

All spindle guides of the old design have been exchanged.

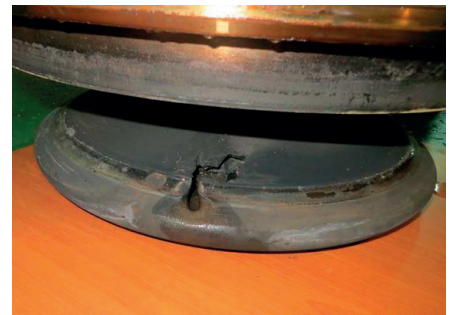
Fig. 36: Blow-by from the seating area

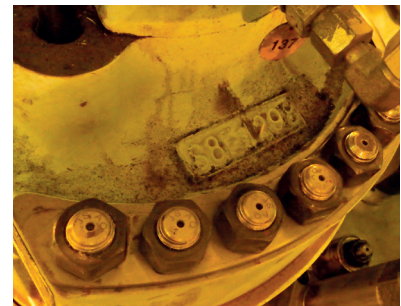
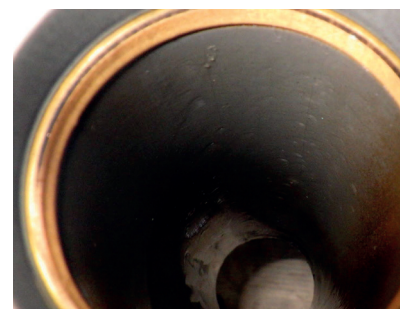
Oil on top of air piston, secure controlled oil level (COL) inside air spring

Multi-studs manually tightened from S60 and down

New spindle design

Clean and perfect spindle guide condition

Fig. 39: Inspection of XV3 exhaust valve on S60ME-C10.5 engine at 5,500 running hours

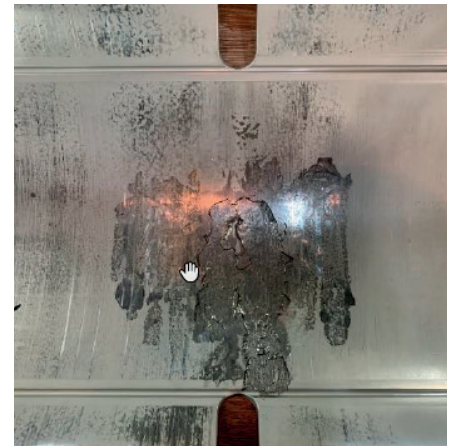
crankpin bearing was not changed. As a result, the bearing centre suffered fatigue damage (Fig. 41) that could potentially develop and spread to the entire bearing shell and spread debris to the crankpin bearing.

Fig. 41: Crosshead bearing centre suffered fatigue damage on G50ME-C engine

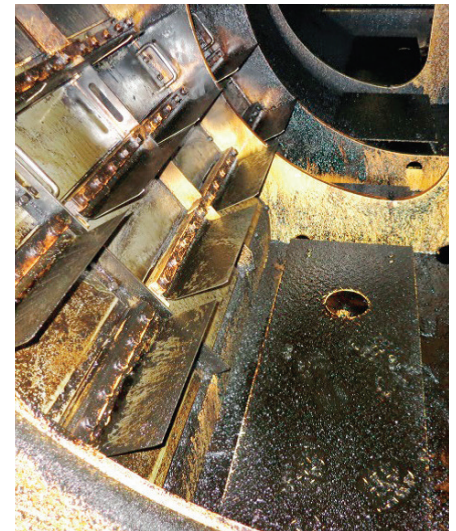
Fig. 44: Sludge and dirt accumulation in the scavenge air receiver when operating on HFO with EcoEGR

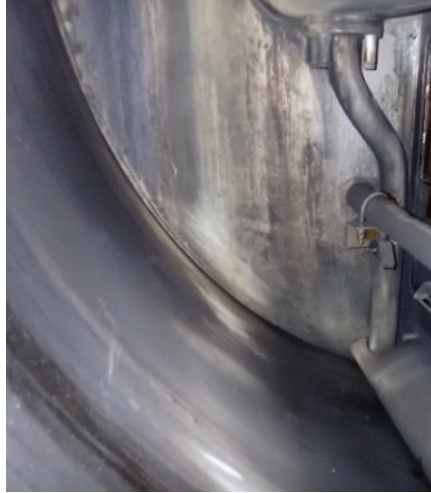
Fig. 45: ME-GI with EcoEGR. EGR unit (below EGR-cooler) with no accumulation of dirt or sludge

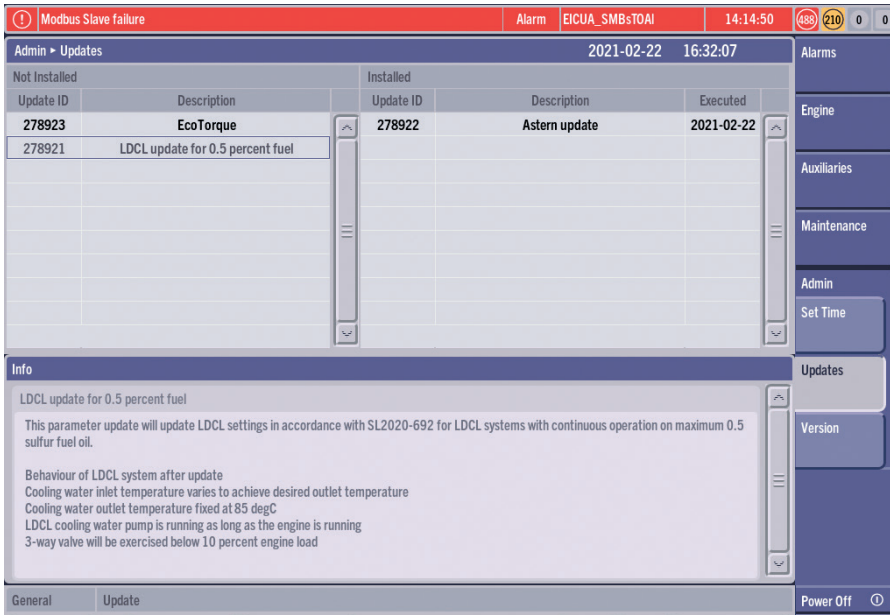
Fig. 49: MOP GUI for PUT

The PUT will work on all electronically controlled MAN B&W two stroke engines. On newer ME-ECS software versions, the installation is handled directly in the MOP GUI like all normal interactions with the MOP, see Fig. 49.

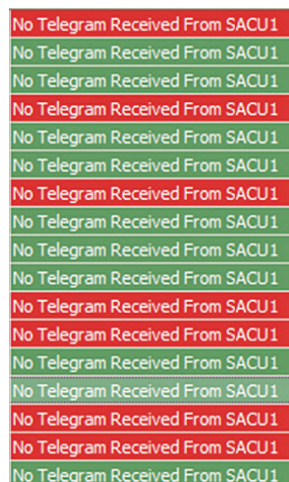
Fig. 51: Missing telegram alarms causing gas shutdown on dual-fuel engines

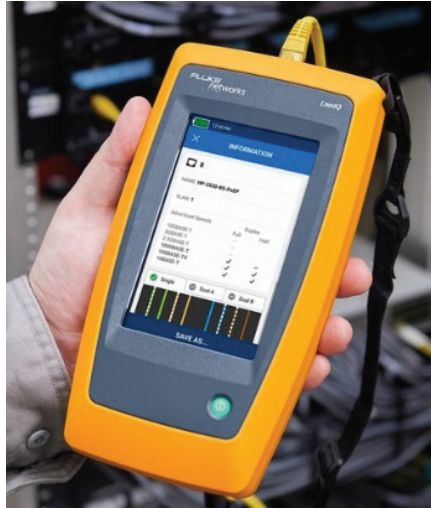
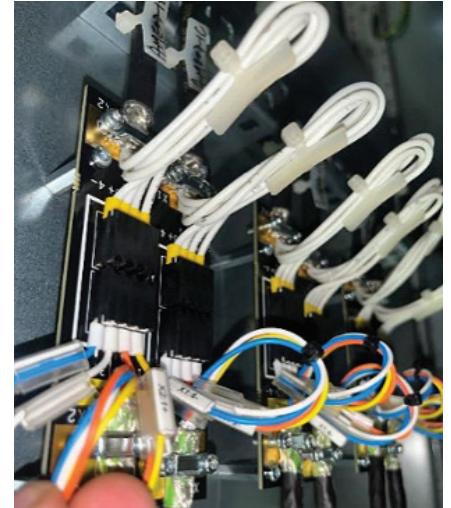
Fig. 52: Installation mistake - unshielded cable loops

It was identified that the network installations were not always made according to the specification that was

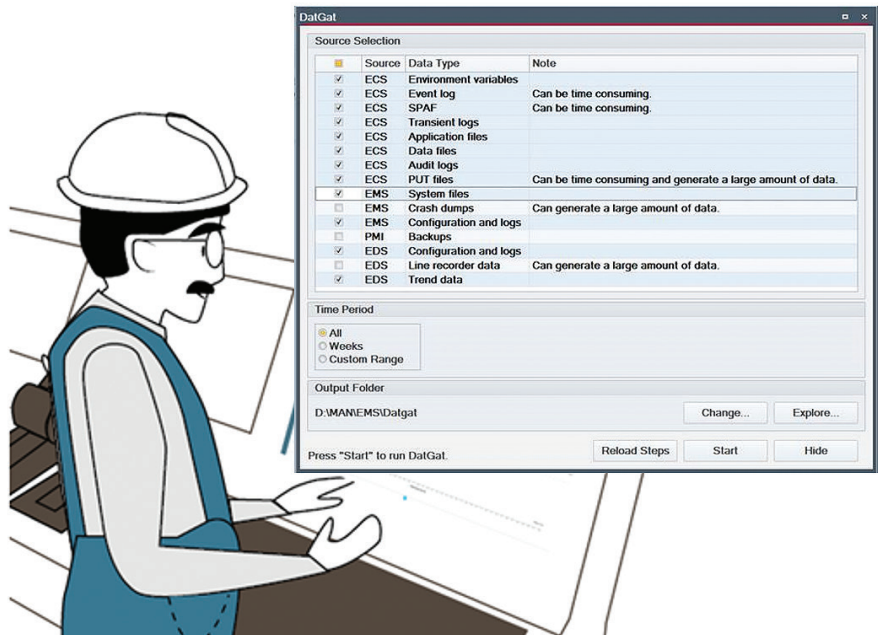
Fig. 54: Current solution on vessels

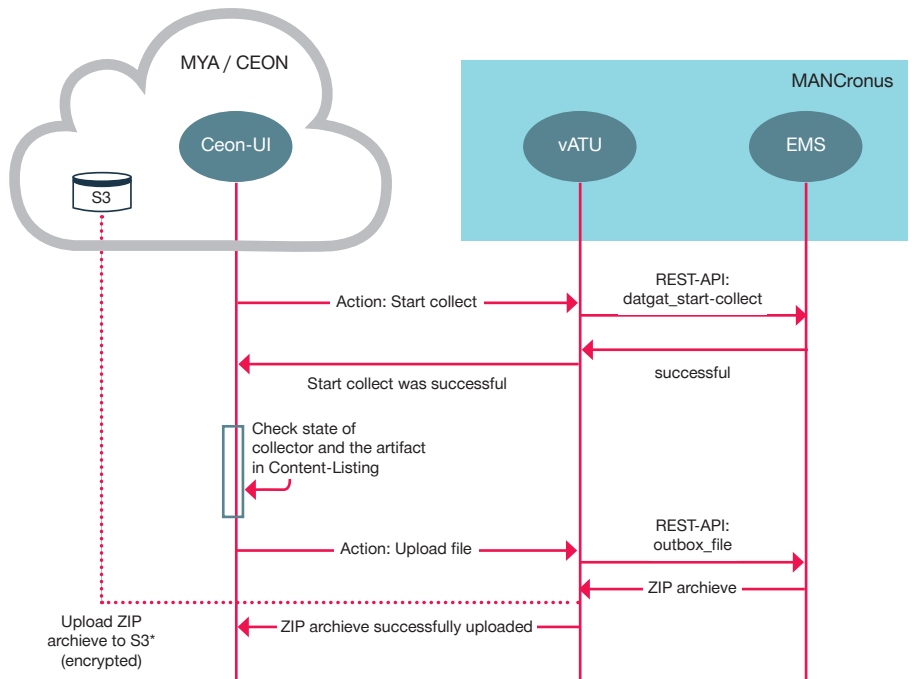
Fig. 55: Working principle of Online Datgat

We have built an API that can be controlled remotely via a secure connection. It is possible to check what data is on the asset, order a new Datgat file, and download it over the internet.

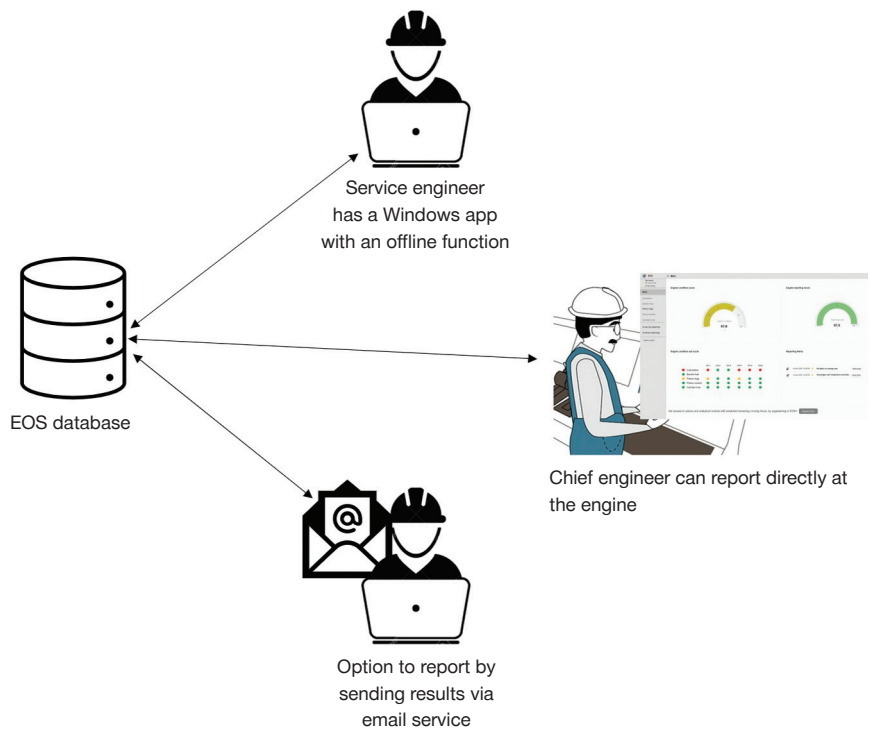
Fig. 56: Principle drawing of input options
