**Starting Air System**

SL2018-668/KNB

Owners and operators of MAN B&W two-stroke marine diesel engines. Type: MC/MC-C and ME/ME-C

Correct maintenance of starting air system to avoid any ruptures

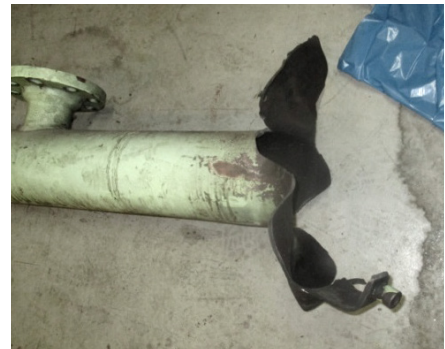
Ruptured starting air manifold

We have recently received reports of malfunctioning starting air systems that led to rupture of the starting air manifold. Based on our findings in these cases we would like to emphasise the importance of correct and timely overhaul of the starting air system and of the main engine in order to minimise the risk of suffering personal injuries or causing damage to the engine. Correct and timely maintenance is to be carried out according to the instruction manual delivered with the engine.

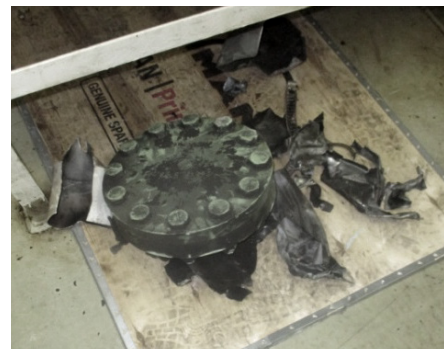
Blind flange at fore-end of the starting air manifold

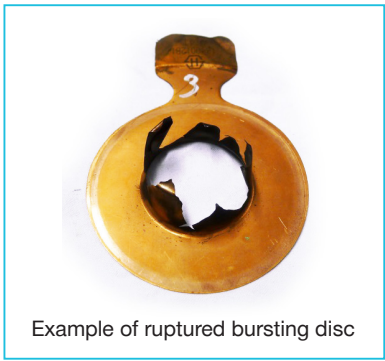
Fig. 1 Starting air system

The bursting disc at the starting air valve in the pipe branch for the cylinder cover is designed to withstand the 30 bar starting air pressure but will rupture in case of a significantly higher pressure and in this way protect the starting air manifold, non-return valve and main starting valve.

- 1. Starting air valve
- 2. Drain/venting pipe
- 3. Starting air manifold
- 4. Bursting cap and bursting disc
- 5. Drain/venting pipe
- 6. Main starting valve
- 7. Starting air supply
- 8. Non-return valve

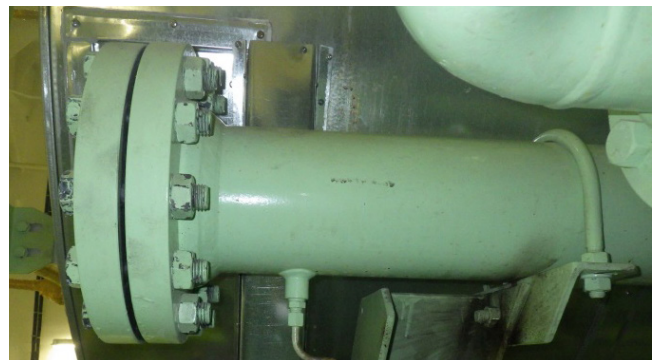
Fig. 3: Drain/venting pipe at starting air manifold at blind end (lowest point of starting air manifold).

- The drain point positioned at the starting air manifold must always be open to ensure free drainage based on gravity.

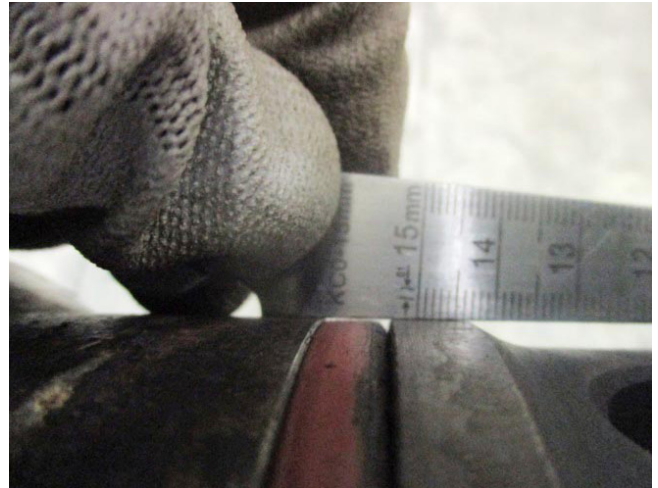
Fig. 6: Example of an O-ring with no sealing effect in the starting air valve. Please note the light between O-ring and steel ruler, which indicates that there is no sealing effect.

It is important to check the condition of the sealing ring for the starting air valve and exchange it, if needed. We strongly recommend also to change the O-ring to a Fluoro rubber O-ring if the present O-ring is made of silicone rubber, as the Fluoro rubber is a more robust O-ring. O-rings made of silicone rubber may decompose during service and thus not last the expected 12,000 hours as stated in the current Service Letter for guidance overhaul intervals. We recommend that only original Fluoro rubber O-rings are used. The mentioned colours of the O-rings are solely referring to the products delivered or purchased through MAN ES. The colour may deviate for O-rings supplied otherwise. Please contact the supplier (engine maker) to clarify the material.

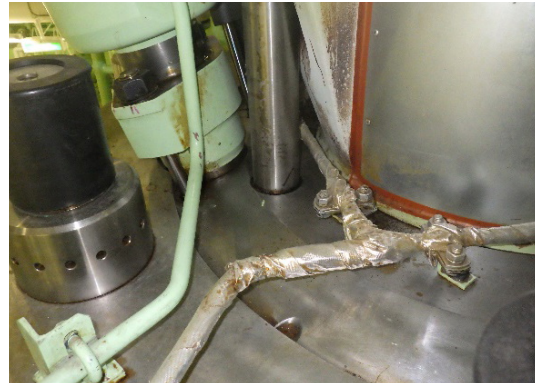
2. Check for air leakage from O-ring sealing between cylinder cover and start valve.

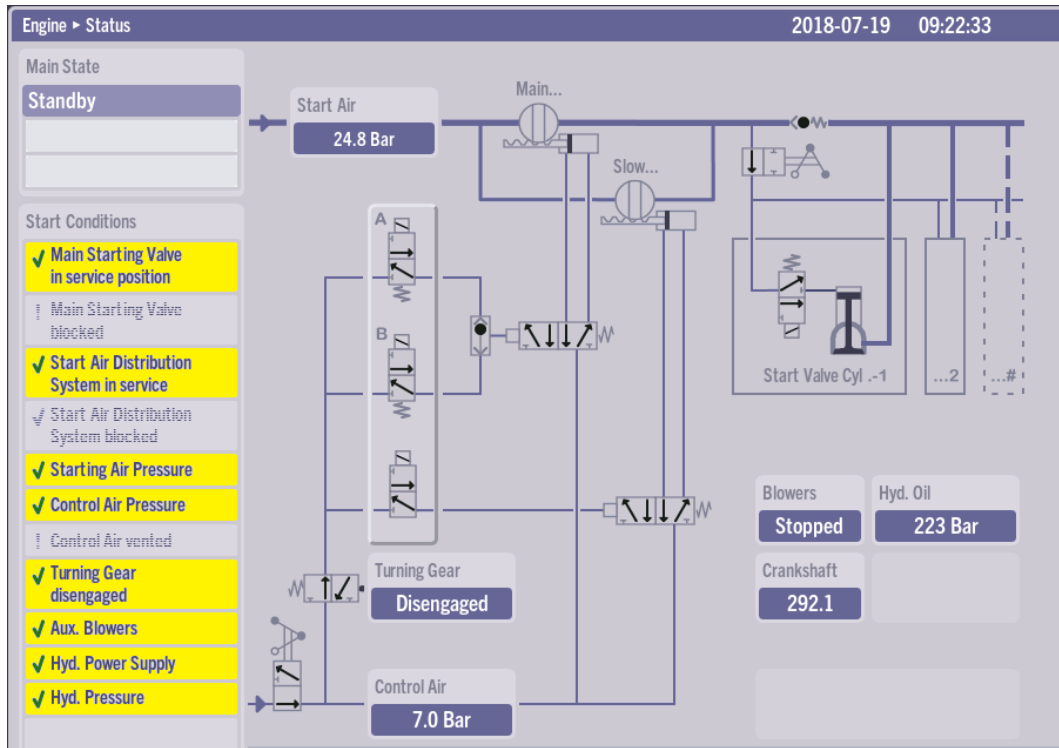
Fig. 9: Engine in standby condition – Ready to start without any start blockings or shutdowns.

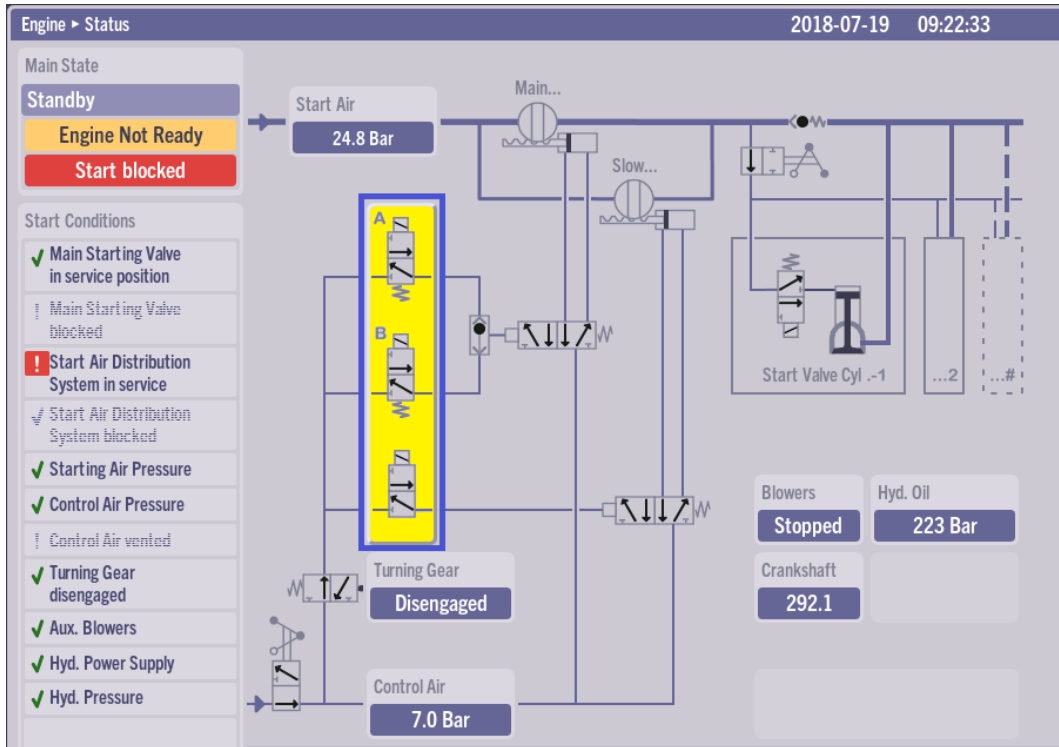
Fig. 11: Select test function of three (3) solenoid valves – marked yellow above.

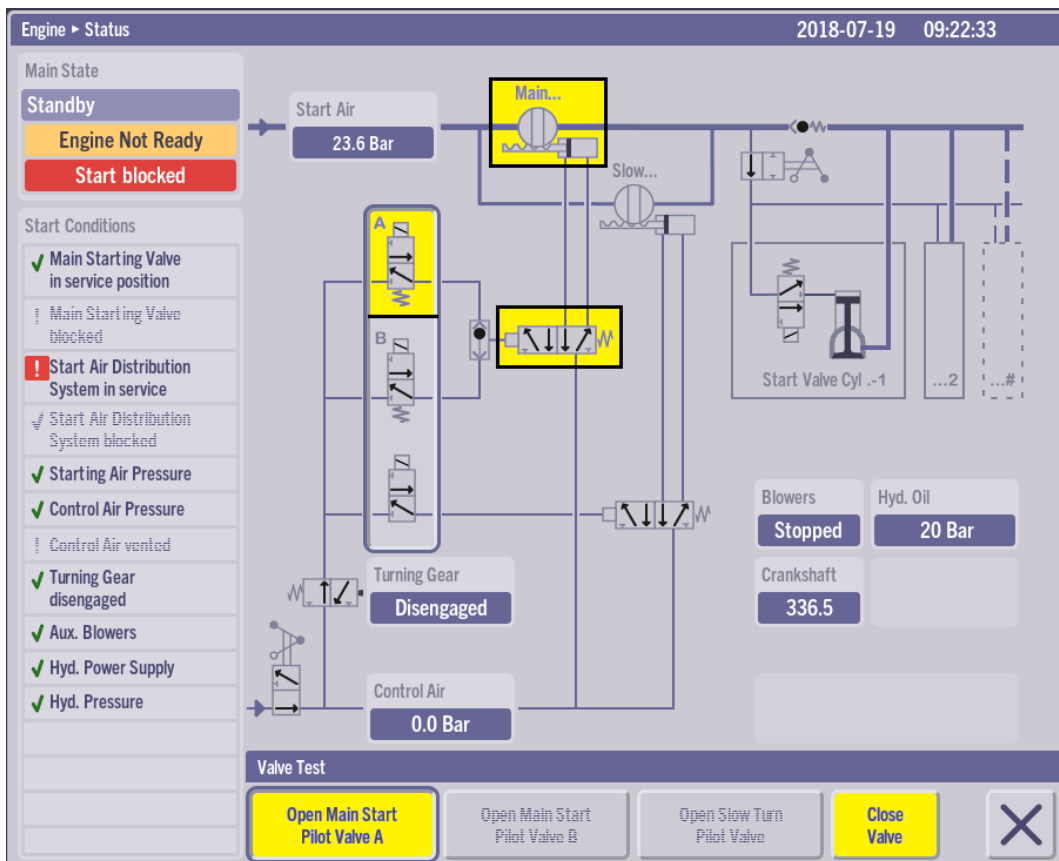
Fig. 14: Test: Open main starting valve (A or B) – Check for external air leakages – Close valve.
