New Shaft Sealings for Cooling Water Pumps

SL11-547/BTT
July 2011

Owners and operators of MAN Diesel & Turbo four-stroke diesel engines.
Type: Propulsion L27/38

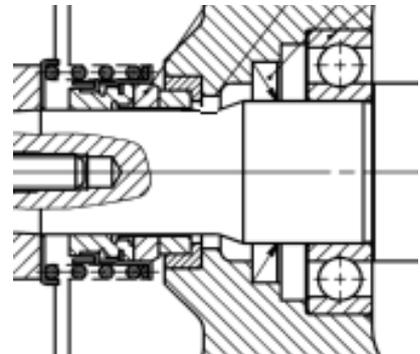
Some examples of cooling water leakage into the engine lubricating oil have been reported from operators of propulsion engines in service. Investigations have revealed that the lip seal (item 013 on the attached drawing) has been damaged due to insufficient temperature capability of the lip seal. Due to the positioning of the telltale hole for oil/water leakage, a leaking rotating shaft seal (Item 014 on the attached drawing) can cause the cooling water to enter into the engine crankcase through the lip seal, without indication at the telltale hole.

In order to minimize this risk, a new type of lip seal made in a different material has been implemented as our standard.

In order to improve the durability of the rotating seal, we have also chosen to change supplier of this seal as of February 2011.

The new type of lip seal and rotating seal are fully interchangeable with the old types and can be purchased from our Spare Part Department. Only the new types will be available.

We recommend that the vessel's technical crew keep an eye on the cooling water consumption and check the water content in the lubrication oil on a regular basis, until the new seals have been installed.
