Sulphur corrosion package

SL2019-677/JNN

Owners and operators of
MAN four-stroke diesel engines.

Marine: L21/31

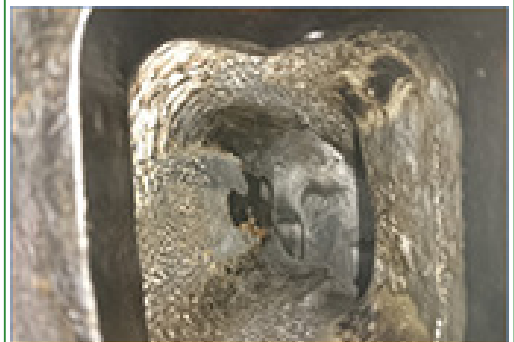
Service feedback from operators has recently revealed some incidents of excessive corrosion in the exhaust duct at the cylinder head of the engine type L21/31.

The corrosion is observed on engines operating on HFO with a high sulphur content. The extent of the corrosion depends on the load profile and sulphur content in the fuel.

It is caused by condensation of sulphur acid on the relatively cold wall of the exhaust duct. High sulphur contents and operation at low load accelerate the corrosion.

Due to the above, it is crucial to maintain a correct cooling water temperature in the high temperature (HT) circuit of the engine. Therefore, we draw attention to the importance of frequent checking of the engine performance parameters, including the HT cooling water temperature. In case the temperature has decreased beyond the normal values mentioned in the instruction manual, we strongly recommend inspecting the HT thermostatic elements. Our service department has reported cases with failing thermostatic elements caused by corrosion / cavitation on the sealing surface of these, see the following pictures for reference.

If sulphur corrosion cannot be avoided by maintenance of the cooling water system, we have prepared a retrofit cooling water temperature control package aiming to increase the temperature on the exhaust duct wall.
