Check of wiring for actuator

SL2019-678/JNN
August 2019

Owners and operators of
MAN four-stroke diesel engines.

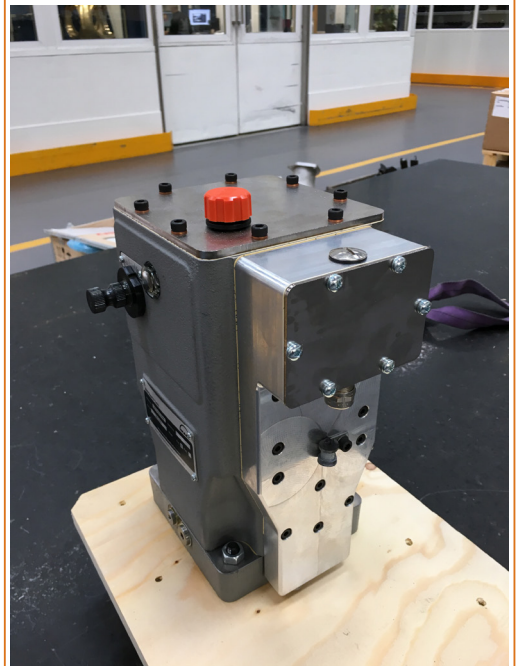
In the cases reported, an insulation failure has occurred on the wiring connecting the control module to the speed actuator. The cause for the insulation failure has been located to the wiring in the terminal box on the actuator.

As a precaution, we recommend to inspect the wiring in the terminal box at the first opportunity. At the inspection, it must be checked that the connection is installed in such a way that the wires do not touch the cover of the connection box. In case of any signs of wear on the insulation of the wires, the damaged part is to be cut off. The connection terminals are of the spring-loaded type, ferrules may be applied at the cables, we however in this particular case recommend removing the cable ferrules, if installed, and connect the wires directly in the terminal strip.

After reconnecting the wires, it must be ensured that no wire can be in contact with the cover. Remove the six screws in the front cover of the actuator to get access to the terminal strip.
