MAN Energy Solutions

Updated procedure due to potential crack in piston crown Replaces SL2023-743

SL2023-747/PRP November 2023

Work Card No. <u>8865-4204-0001</u> Special piston lifting

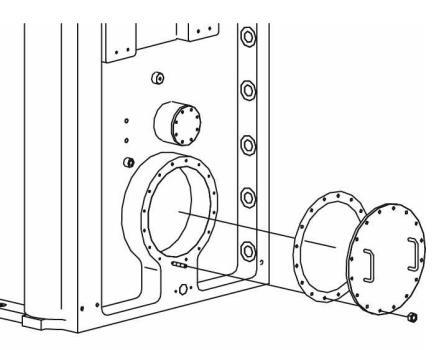
8865-4204-0001C01

Open the acces hatch to the scavenge air reciever and remove the acces cover of the scavenge air box for the relevant cylinder.

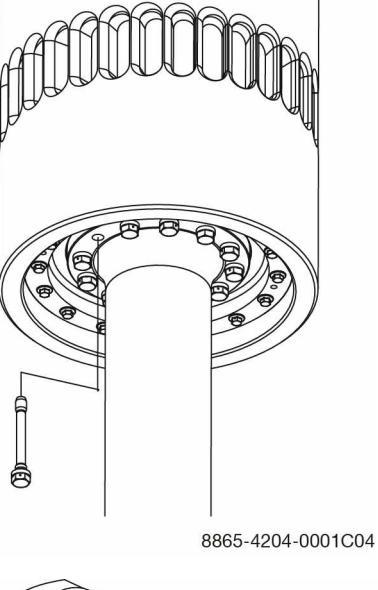
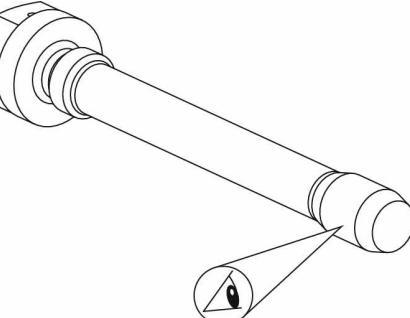
8865-4204-0001C05

Remove the locking wire from one of the screws connecting the piston rod and the piston crown. Loosen and remove the screw from the piston

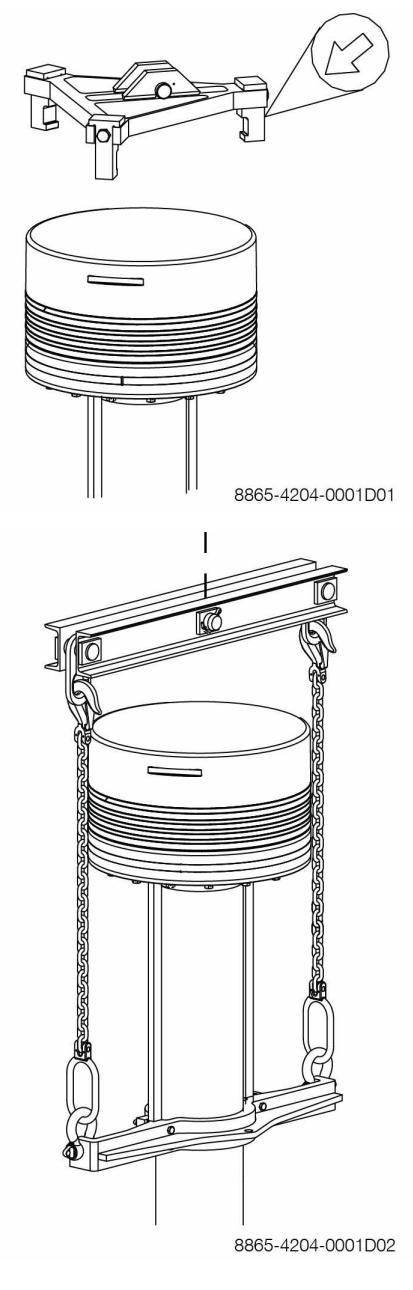
Mount the piston lifting tool on the piston crown as described in the standard piston instruction [M90201] or [2265-0401].

If a collar ring (piston lifting tool for low lifting height conditions) is available remove the piston from the engine as described in instruction [M91309].

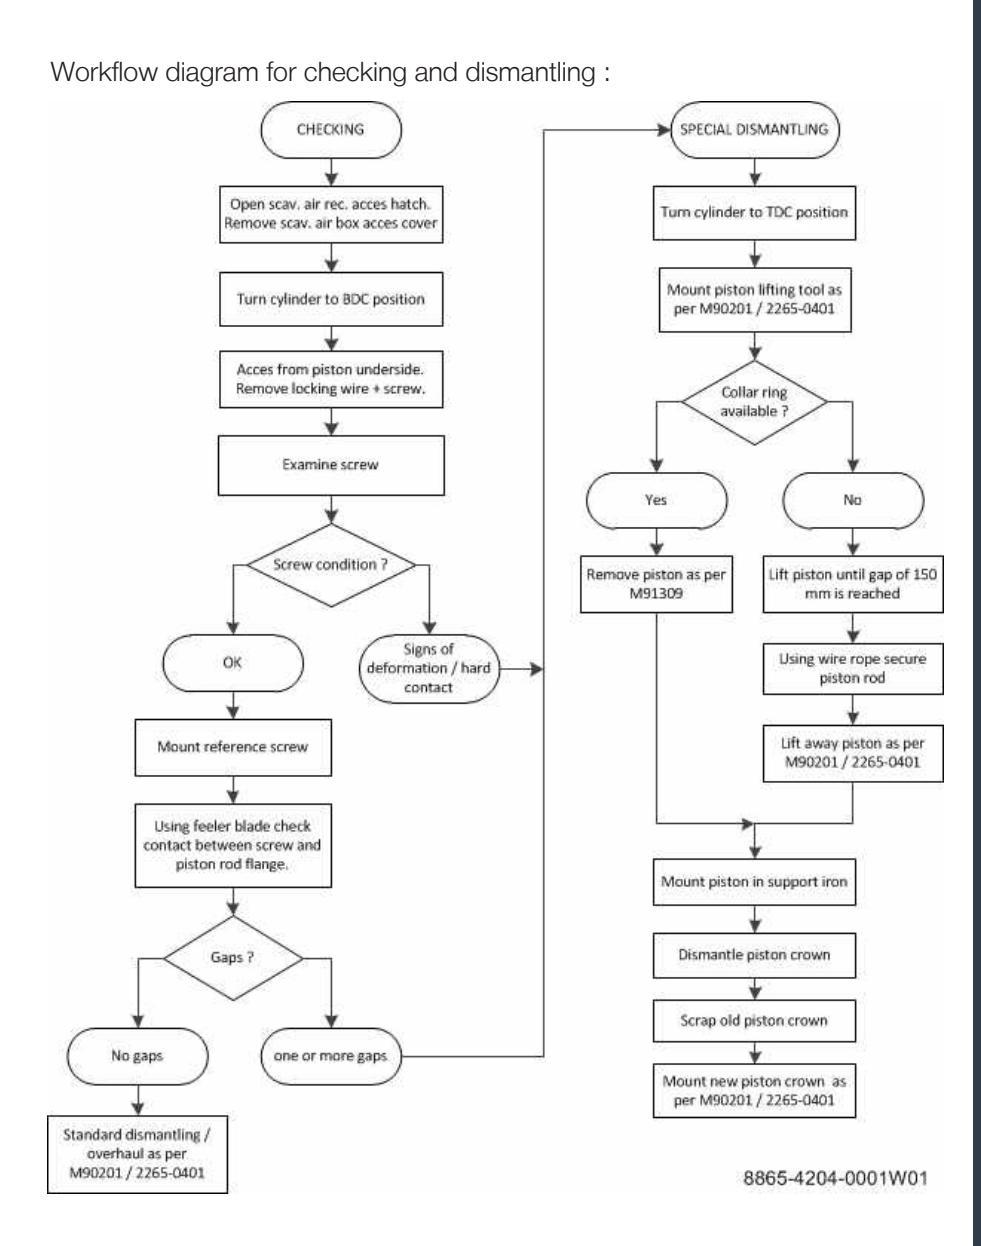
Workflow diagram

If the screw shows signs of deformation or hard contact OR if a gap is found between the reference screw and the piston rod flange, as described in steps 4 and 6 of the checking section of this S-instruction, then special running with that cylinder cut out of action and the exhaust valve in fixed open position is NOT allowed.

▲ CAUTION Special running may NOT be carried out until the piston crown of that cylinder has been replaced.
