Piston skirt design update

Bronze band piston skirts updated to Mo-based piston skirt with barrel shape

SL2023-746/HRA November 2023

Owners and operators of MAN B&W two-stroke marine diesel engines. Type: MC/MC-C and ME/ME-C

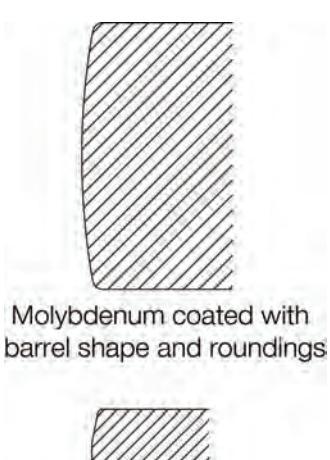
Non-coated with chamfers and bronze band(s)

The Piston skirt may be either *Molybdenum* coated and barrel shaped, or non-coated with 1 or 2 bronze bands.

See the sketch showing the running surface of the skirts (details exaggerated for visibility).

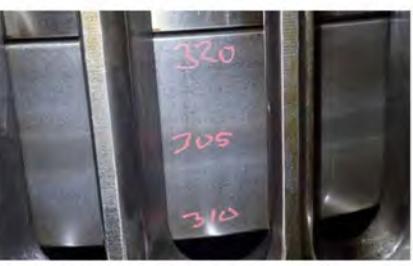
The level of wear on the barrel shape geometry can be seen by the height of the skirt center contact zone. If the contact has increased to the full height of the skirt, the barrel shape is worn out.

Light barrel shape skirt wear

11. Piston skirt replacement cri- If either the skirt barrel shape is worn away **or** the Mo-coating is worn through to the cast iron base material in any position, the skirt should be replaced when convenient.

If both the barrel shape is worn away **and** the Mo-coating is worn through in any position, the skirt must be replaced as soon as possible.

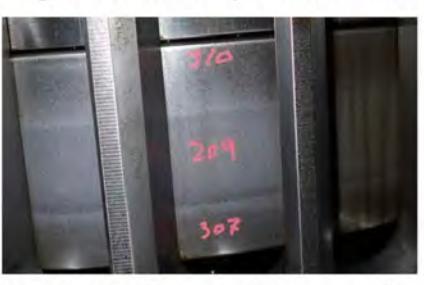
Moderate barrel shape skirt wear

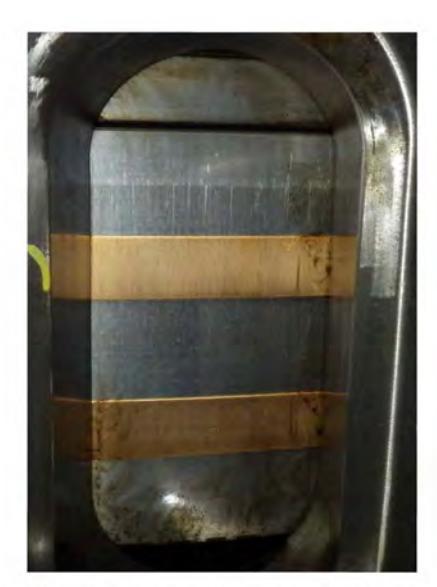
In the middle of the skirt running surface 1 or 2 bronze bands are mounted. At the top and bottom of the skirt running surface a chamfer of 7-25 mm height is cut (depending on engine bore size).

As new, perfect condition

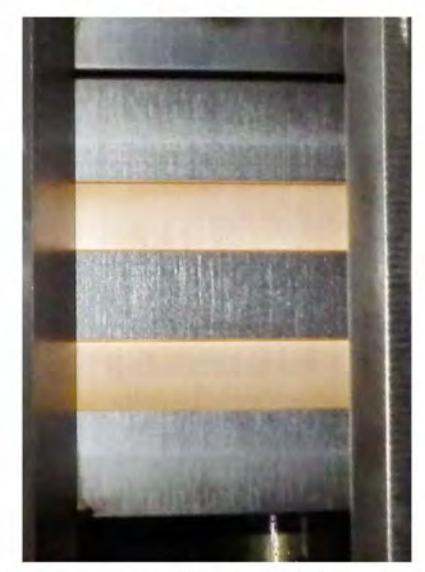
- Wear of the bronze band(s) is natural and does not require replacement.

Bronze bands worn flush, but chamfers in fine condition.

- When the chamfer is worn flush with the skirt running surface in any position, that is the chamfer has locally disappeared, the skirt is worn out and must be replaced as soon as possible.
