# On-site recovery

## MAN PrimeServ

# Cylinder cover recovery

## In-situ machining and welding

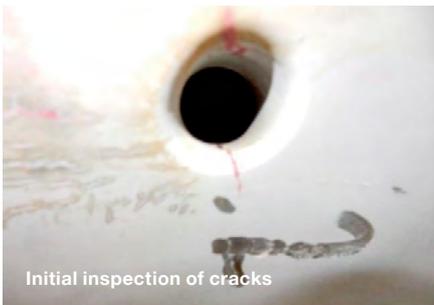
Initial inspection of cracks

- 1 **Inspection of cracks**
- 2 **Removal of Inconel padding by milling**
- 3 **Drilling out the cracked fuel injector hole**
- 4 **Preheating & Inconel welding**
- 5 **Final machining of injector bore**
- 6 **Final inspection**

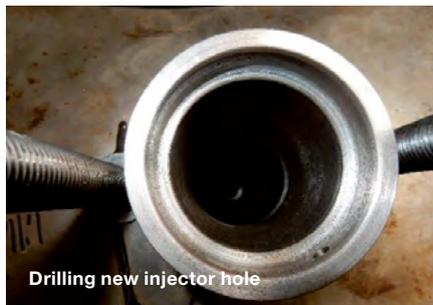
Drilling new injector hole

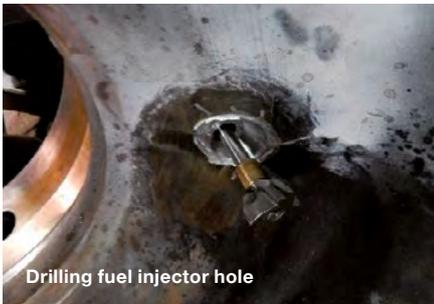
Drilling fuel injector hole

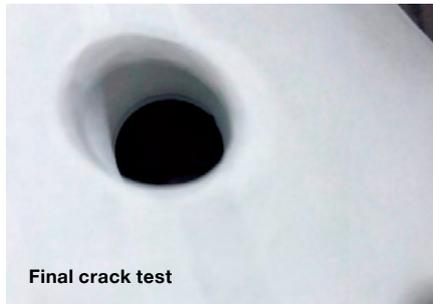
Final crack test

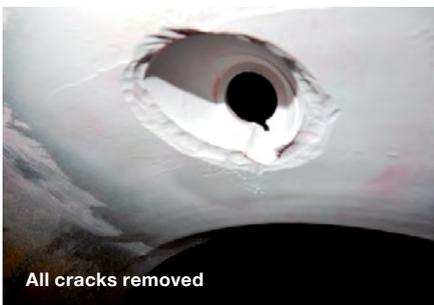
All cracks removed

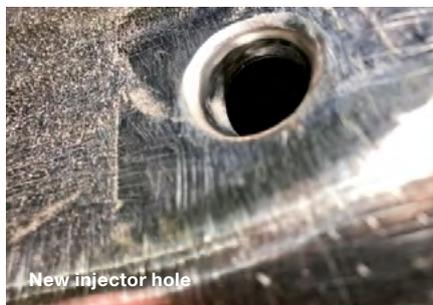
New injector hole
